# **Current Status and the Future of Fukushima Daiichi Nuclear Power Station**

March 2, 2016

Chief Decommissioning Officer,  
President of Fukushima Daiichi Decontamination and  
Decommissioning Engineering Company,  
Tokyo Electric Power Company

# Present State & Future Response to TEPCO's Fukushima Daiichi Nuclear Power Station

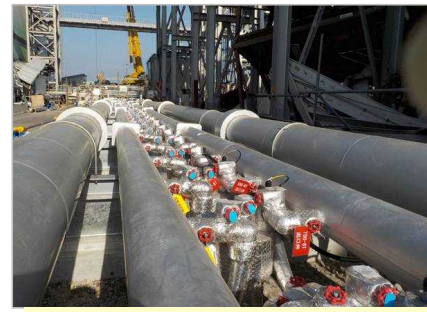
## Fundamental Measure ② Install land-side (frozen soil) impermeable wall

To mitigate the increase in contaminated water and to prevent its flow into port

- Buildings will be enclosed by ice wall to curb inflow of groundwater into buildings
- Full-scale construction began in June 2014
- Construction of the mountain side was completed in September, 2015. As for the sea side, setting of freezing pipes was completed in February, 2016

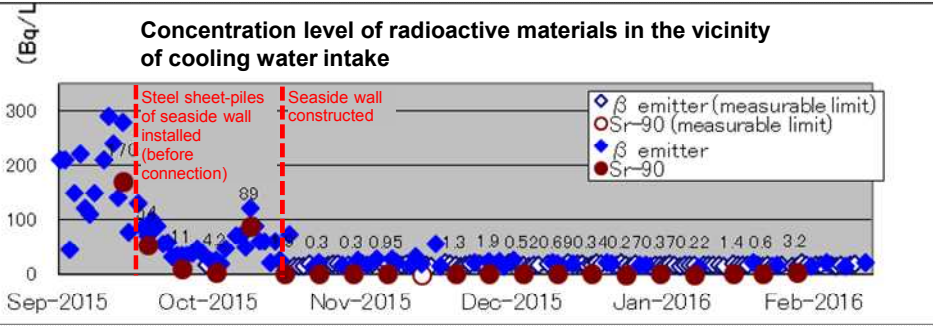
## Fundamental Measure ① Construct sea-side impermeable wall

To prevent flow out into sea

- Construction of steel sheet-piles comprising impermeable wall was completed in October 2015. The radioactive material concentration inside the harbor has become lower

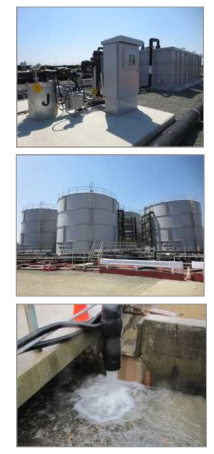
## Emergency Measure ② To pump up groundwater on mountain side of buildings (groundwater bypass)

## To control increase in contaminated water

- Groundwater inflow into the buildings is reduced by pumping up and bypassing groundwater, flowing from the hill side, on the upstream side of the buildings
- Start of water drainage on May 2014 (About 100 times, total 170,000t drained so far)

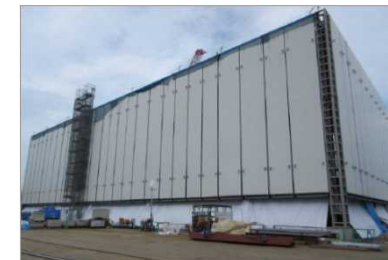
Building for expanded ALPS

- In addition to Existing ALPS facilities, the following two facilities were introduced for early treatment of RO-concentrated saltwater<sup>\*1</sup> stored at Fukushima Daiichi NPS
  - Expanded radionuclide removal systems, improved on the basis of operating experience from the current ALPS (changed adsorbent, extra adsorption towers) to reduce the radioactive concentration
  - High-performance ALPS (project subsidized by the Ministry of Economy, Trade and Industry)
- These are running now

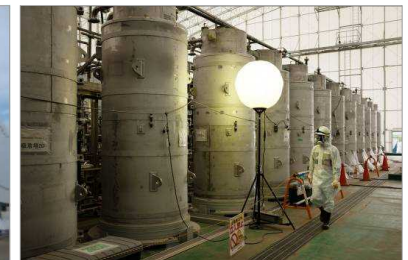
Item	Existing ALPS	Expanded ALPS	High-performance ALPS
Treatment volume	250m3/day/system	At least 250m3/day/system	At least 500m3/day/system
Number of systems	3 systems	3 systems	1 system
Pre-treatment method	Coagulating sedimentation method	Coagulating sedimentation method	Filter type
No. of adsorption towers	14 + 2 towers	18 towers	20 towers
Seismic resistance class	Equivalent to class B	As on left	As on left
Radionuclide purification capacity	62 radionuclides to ND level	As on left	As on left
Waste generation	—	—	Around 1/20 of current ALPS facilities

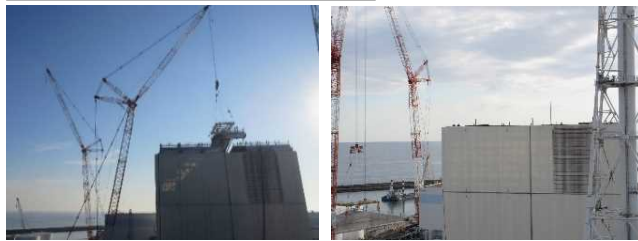
Removal the roof panels

- The building cover was built in October 2011 to suppress the airborne dispersion of radioactive materials
- There is still an accumulation of scattered debris on top of the refueling level within the building cover
- The collapsed roof remains dropped onto the refueling level in a nearly flat shape

Removing (photographed in Oct 2015)

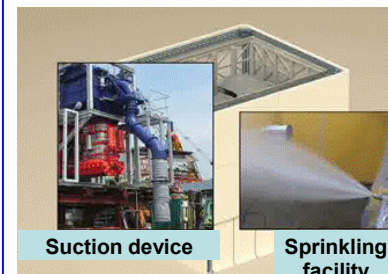
- Suction the dust and rubbles
- Set sprinkling facilities
