Current status of Fukushima Daiichi NPS

- Efforts for Decommissioning and Contaminated Water Management -

Agency for Natural Resources and Energy, METI

March , 2017

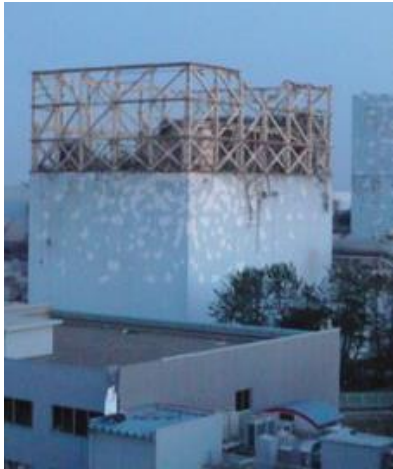
<At the Time of the Accident>

- ✓ Hydrogen explosion
- ✓ Core melt

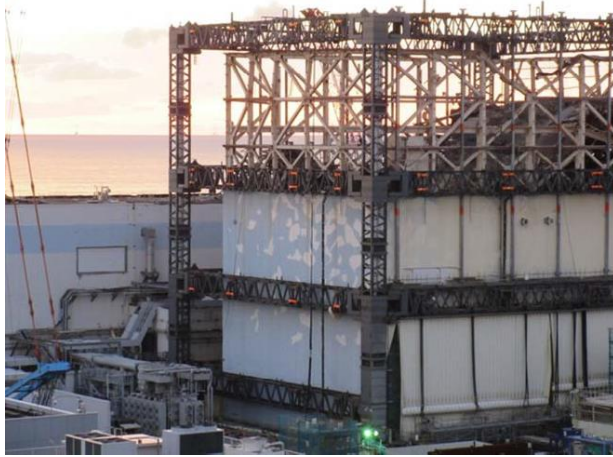
<Now>

- The building cover was installed to prevent dispersion of radioactive materials.
- Dismantling of the cover was completed in November 2016 for the fuel removal operation.

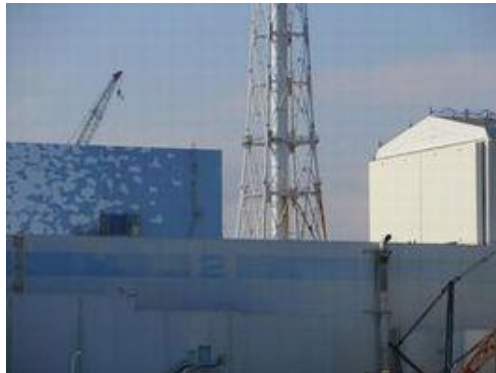
<Now>

- Installing a gantry to access the top floor of the building started in September 2016.

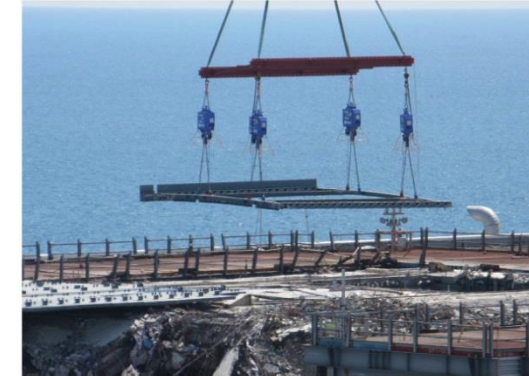
<Now>

- In December 2016, installing shields on the operating floor was completed.
- In January 2017, installing a Fuel-Handling Machine was started.

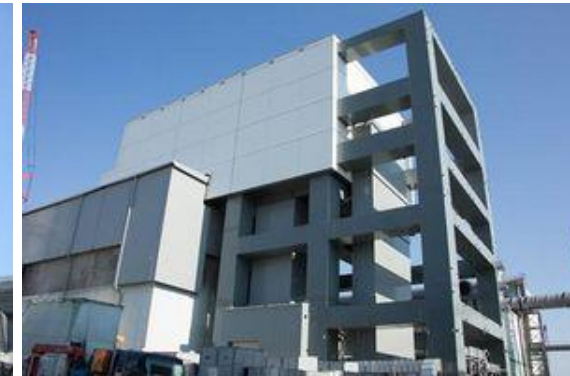
<Now>

- On December 22, 2014, all (1533) fuel removal from Unit 4 SFP was completed.

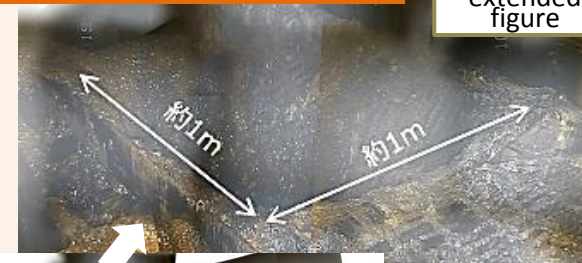
extended figure

Fallen scaffold
