Current Status and Challenges at Fukushima Daiichi Decontamination and Decommissioning

Naohiro MASUDA

**President of Fukushima Daiichi Decontamination and
Decommissioning Engineering Company,
Tokyo Electric Power Company Holdings, Inc.**

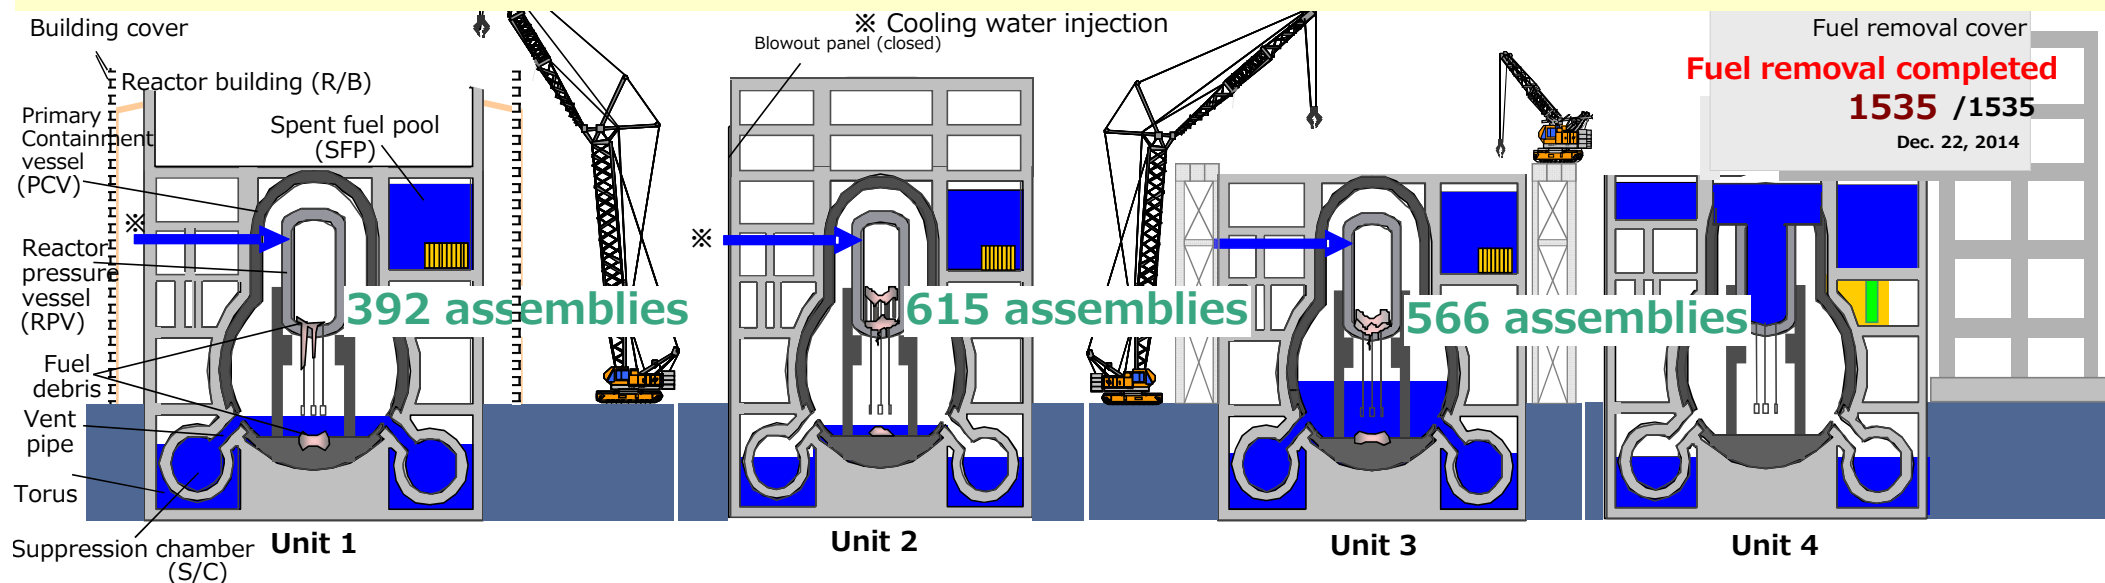
- Cold shutdown of all units continues to be maintained.
- Plant parameters including RPV and PCV temperatures are monitored continuously 24 hours/day

Values as of 11:00 am on February 22, 2017

Temperature at the bottom of the pressure vessel	Temperature inside the containment vessel	Fuel pool temperature	Reactor coolant volume
Unit 1	14°C	15°C	24°C	3.0 m ³ /hour
Unit 2	18°C	19°C	26°C	4.5 m ³ /hour
Unit 3	17°C	18°C	26°C	3.2 m ³ /hour
Unit 4	—	—	14°C	—

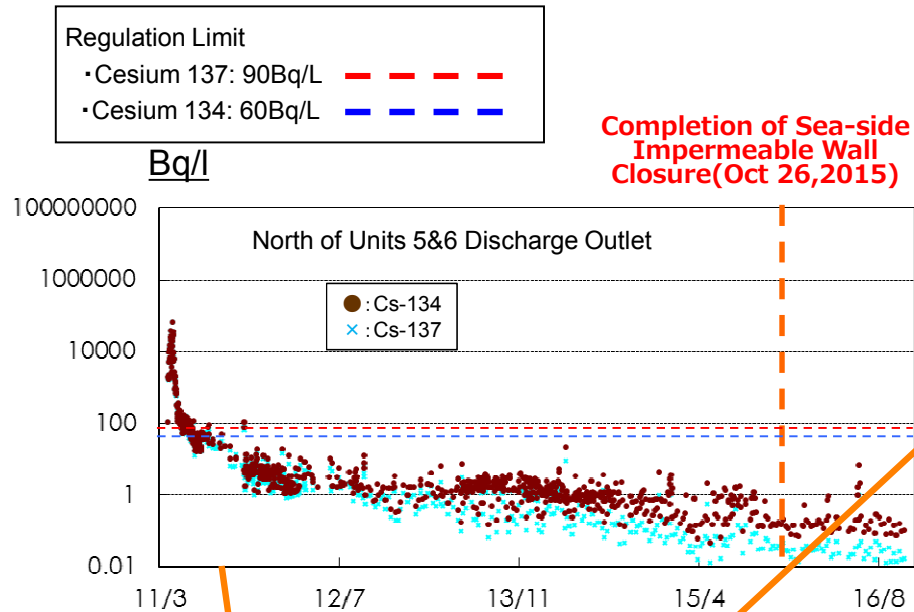
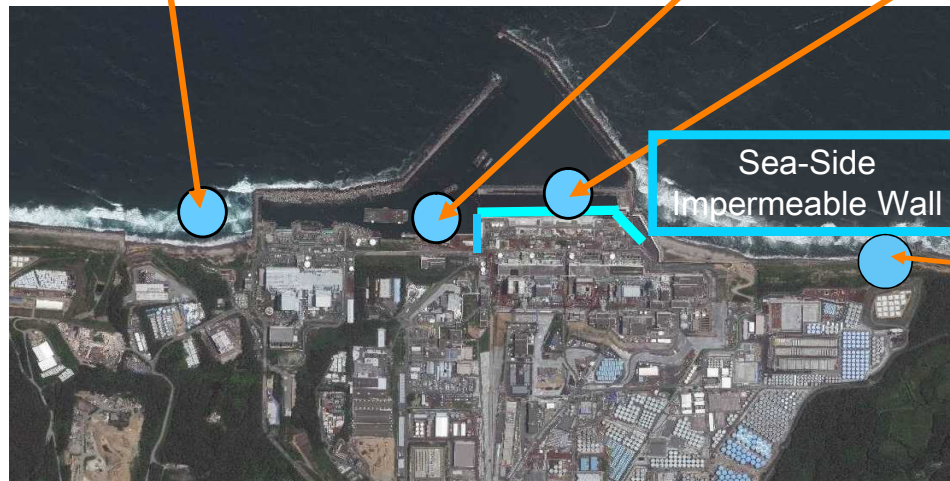
- Compared to the situation just after the accident, the current level of radioactivity has been lowered to parts per hundred thousand, to per million.
- Concentration levels decreased further after closure of the sea-side impermeable wall.

- The concentrations outside the port are substantially below regulation limits

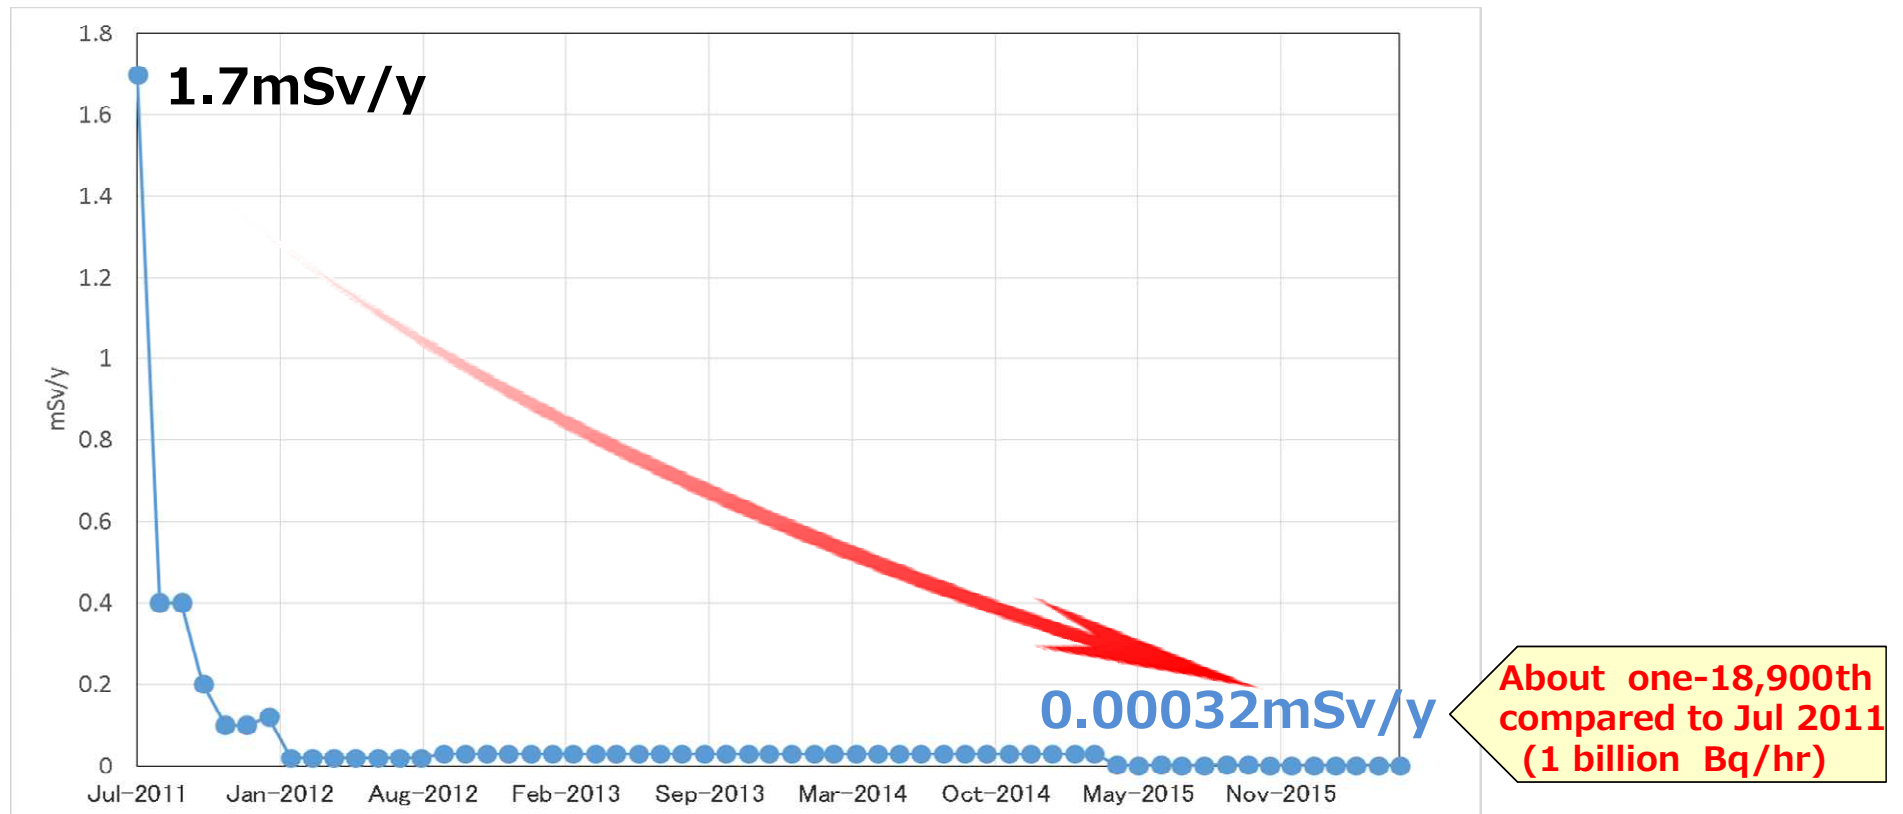
Exposure dose by radioactive materials (cesium) from Units 1 to 4

■ Release of radioactive materials has significantly decreased

Amount of radioactive materials (cesium) released from Unit 1-4 PCVs is assessed based on airborne radioactive material concentrations at top of reactor buildings

Estimated value of total release amount (as of August 2016) about 53 thousand Bq/hr

- Accordingly, assessed the exposure dose at site boundary as maximum 0.00032 mSv/yr
(Excluding effect of already released radioactive materials)

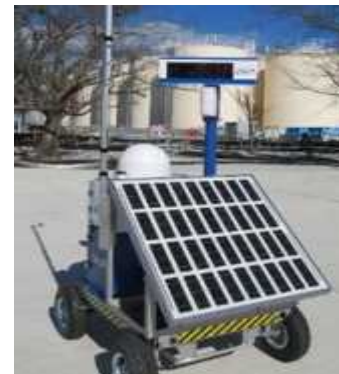
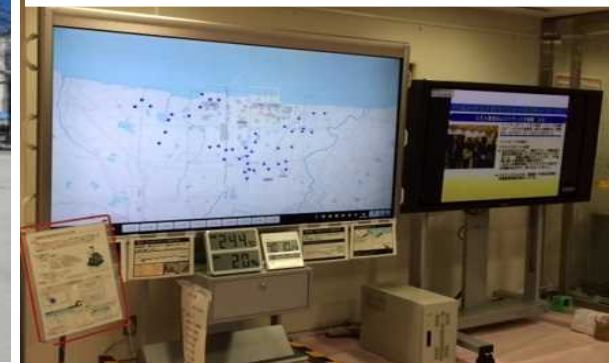
Installation of dose-rate monitors

- System visualizing real time dose data in place.
- Data display monitors (86 points) placed where workers can easily access. Continuous dust monitoring data also shown on display.

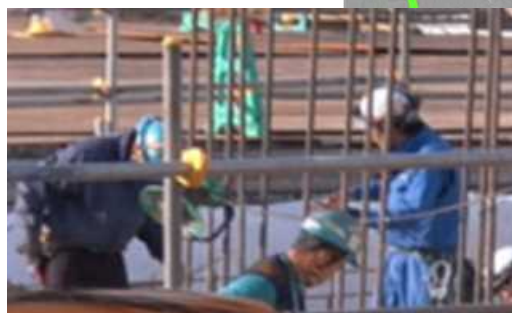
- As a result of radiation reduction measure, workers don't have to wear full-face respirator or half-face respirator anymore in most parts of the site.

Green zone equipment

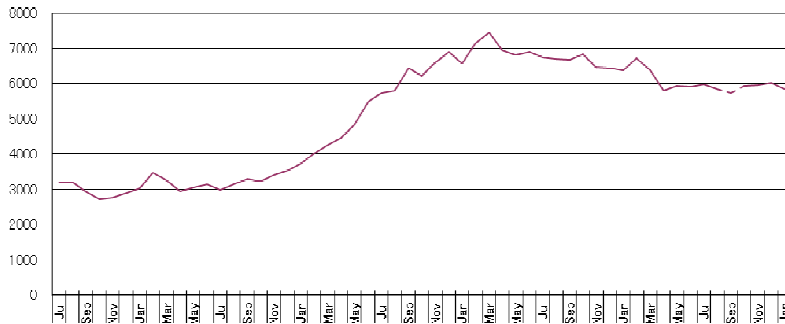
Changes in number of workers

- Number of workers (TEPCO employees and contractors) per weekday engaged in work during October assumed as approx. 5,850 people as of Jan. 2017.
- Percentage of workers from local area approx. 55% as of Jan. 2017.

Change in the average number of workers (actual value) per weekday in the months following 2012.
