3. Three Policies for Measures to Counter Contaminated Water

4. Fuel Removal from the Spent Fuel Pools

5. Toward Fuel Debris Removal

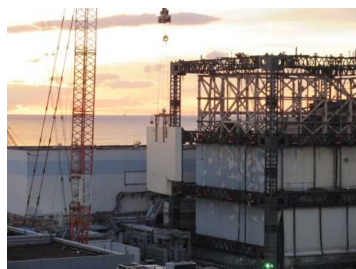
Unit 1

Removal of cover panels toward removal of fuel from spent fuel pool is complete

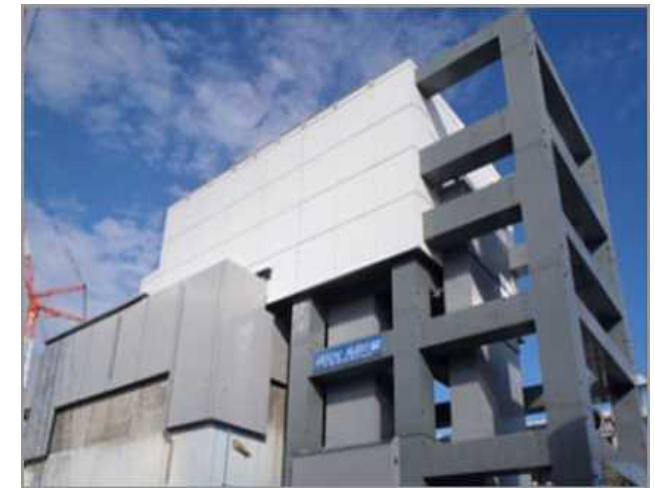
November 12, 2013:
Completion of building steel
framework (The volume of
steel used is equivalent to
those of Tokyo Tower.)

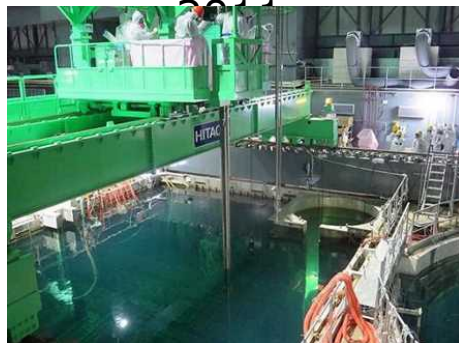
Process of removing fuel rods at SFP Unit 4

- Fuel removal started on November 18, 2013.
- Removal of 1535 fuel bundles completed on December 22, 2014 as scheduled
- No risk from fuel remains at unit 4. This gives confidence to proceed to fuel removal at units 1, 2 and 3

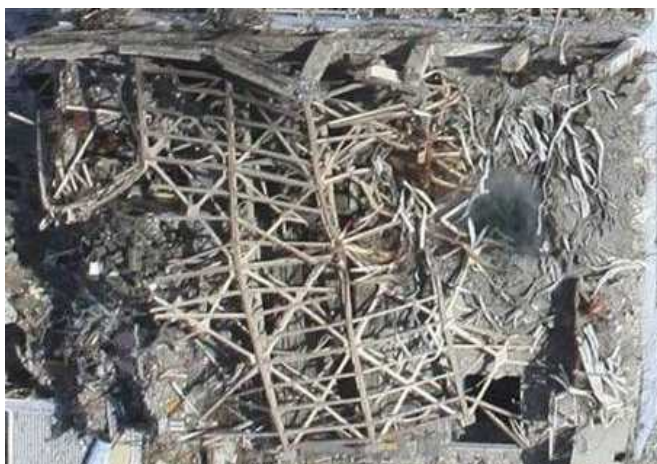
Mar. 2013

Before removal of large pieces of rubble

- Removal of large pieces of rubble on the refueling floor and spent fuel pool was completed in 2015.
- Decontamination work was completed in June 2016 and shielding was completed in December 2016.
- In January 2017, the work for installing fuel removal cover started.
- Fuel removal will take place in the middle of FY2018.

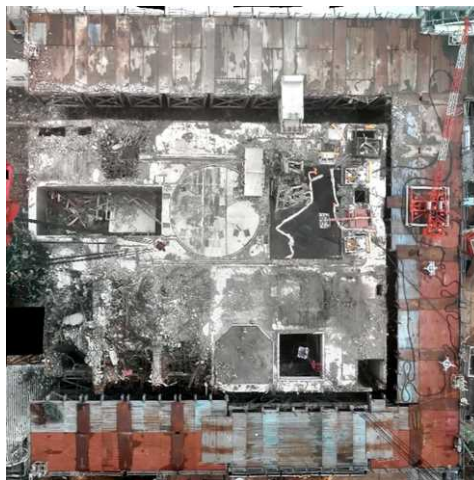
Feb. 2016

After removal of large pieces of rubble

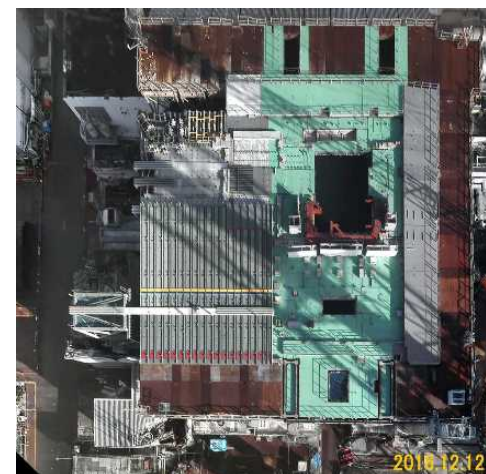
Dec. 2016

After Shielding

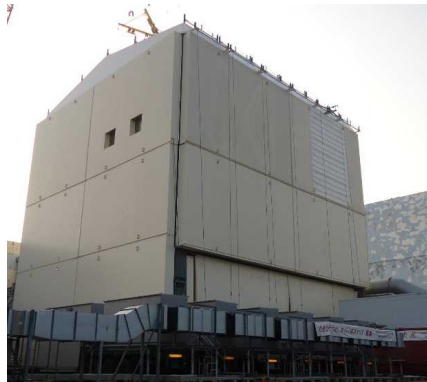
Complete installation
(Oct. 2011)

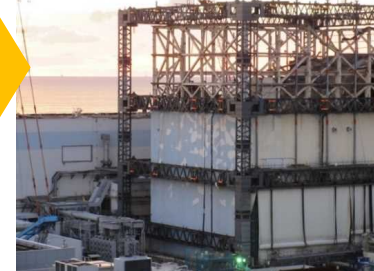
Complete removal
(Nov. 2016)

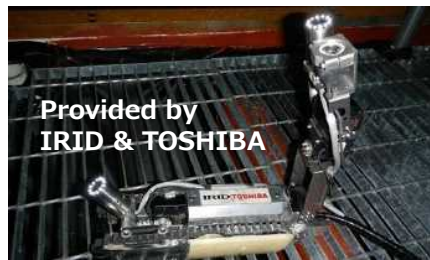
Robot for Survey

The head camera with a lamp had a tilting and panning function. The robot also has a dosimeter and a thermometer.

- Exploration inside the PCV and at the bottom of the RPV was conducted in order to investigate conditions such as the location of fuel debris inside the PCV.
- X-6 opening was used as a path for devices shown below to proceed inside the pedestal.
