FPCJ Press Briefing

Fukushima Daiichi Decontamination and Decommissioning : Current Status and Challenges

February 25, 2019

President of Fukushima Daiichi Decontamination and
Decommissioning Engineering Company,
Tokyo Electric Power Company Holdings, Inc.

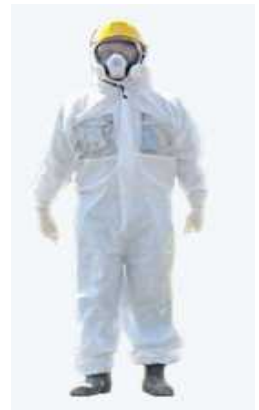
Area where people should work in protective gears

Area where people can work in general uniforms

【96% of the site】

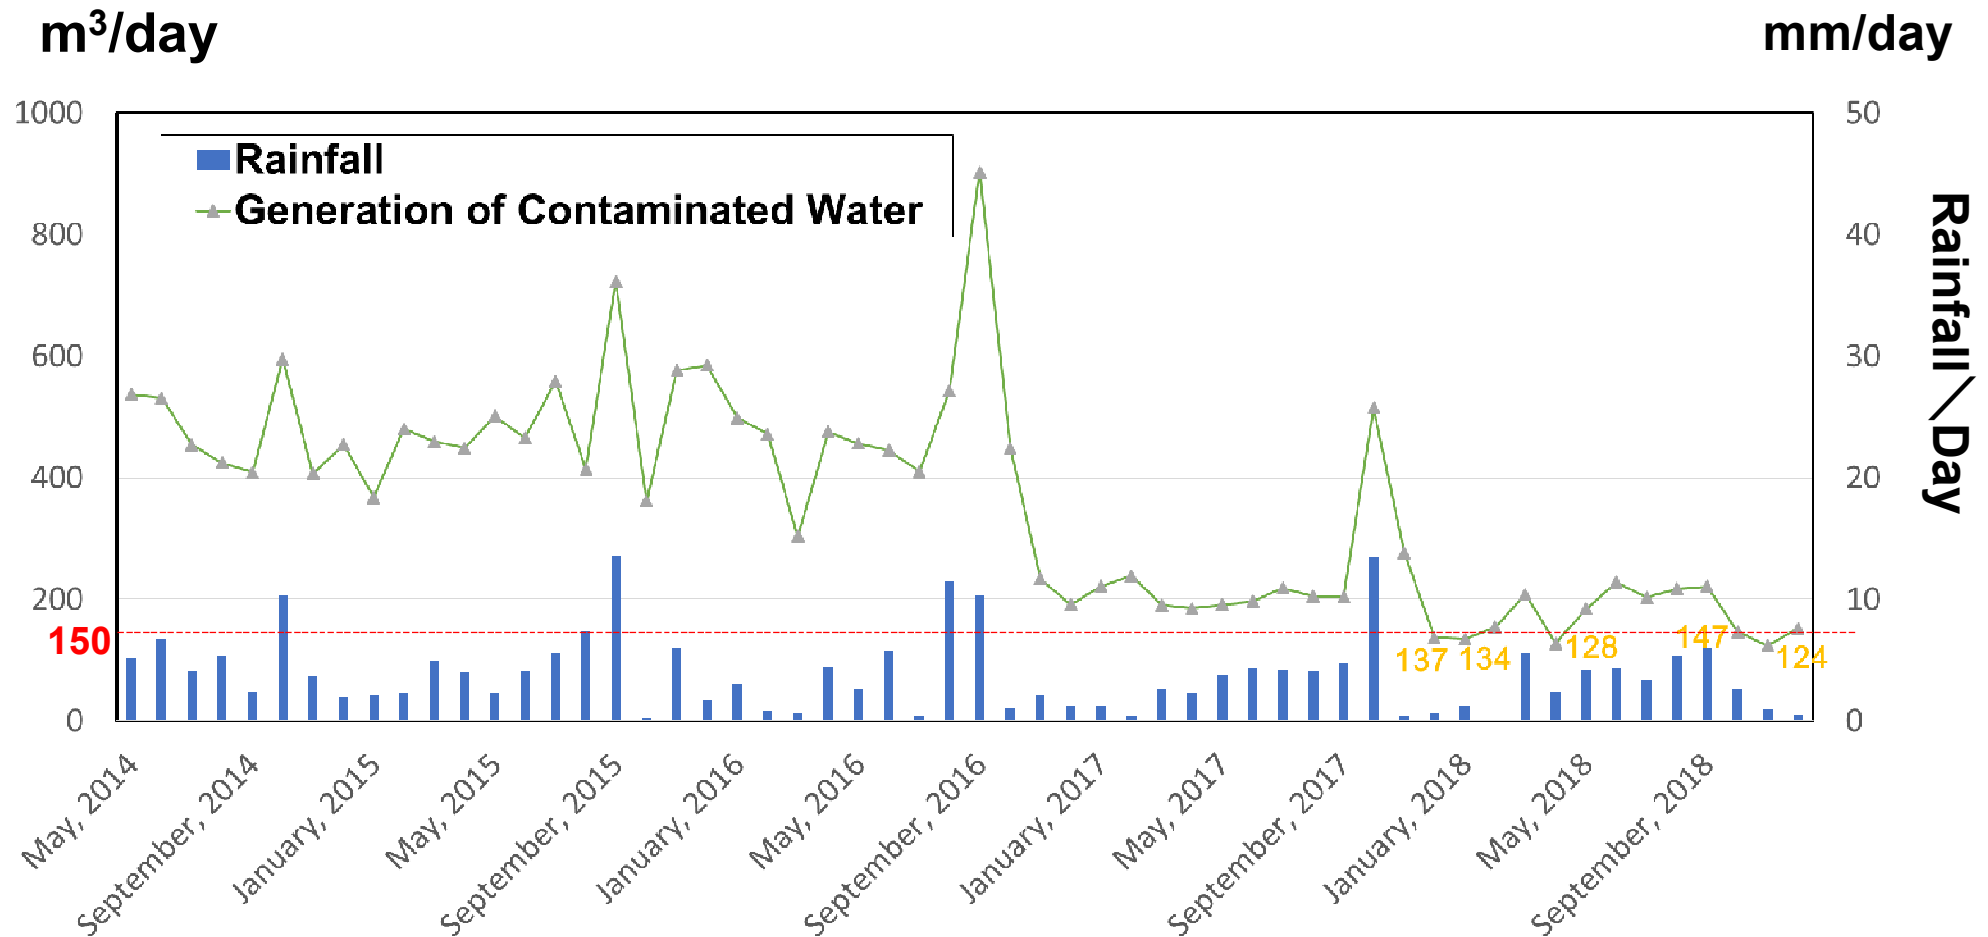
Contaminated Water Generation / Day

- Generation of the contaminated water decreased to 220m³/Day (average value in FY 2017) from 470m³/Day (average value in FY2014 when countermeasures have not been taken) as a result of multilayered measures.
- Will continue to take additional measures against the inflow of rainwater etc., and aim to reduce the generation to 150m³/day on an annual basis within FY2020.

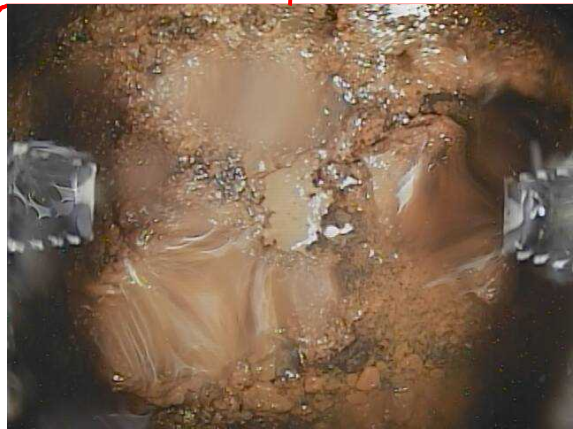
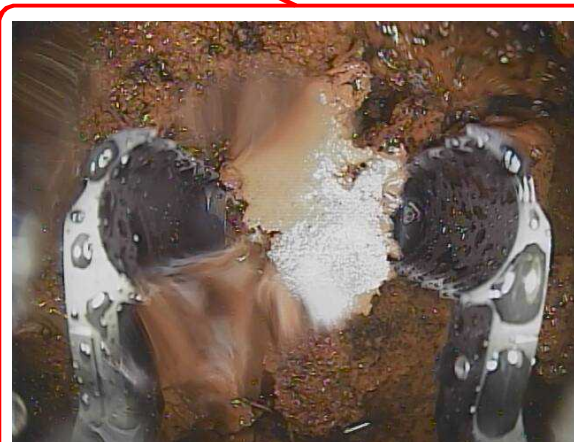
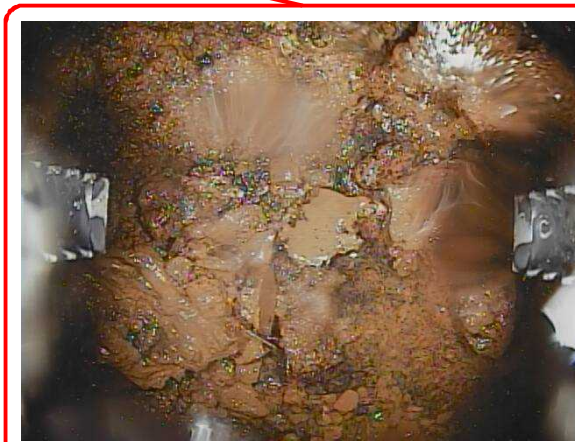
- In order to understand the mobility of deposits found at the bottom of the pedestal, a new guide pipe modified from the existing one was used.
- Five out of the six investigated locations have been found to have movable pebble-like deposits.

Before touching deposits

During touching deposits

After touching deposits

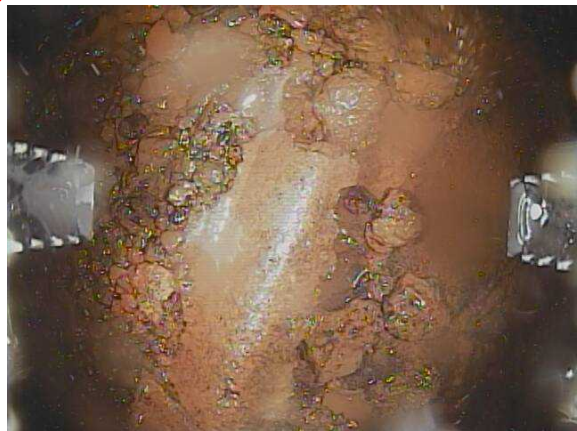
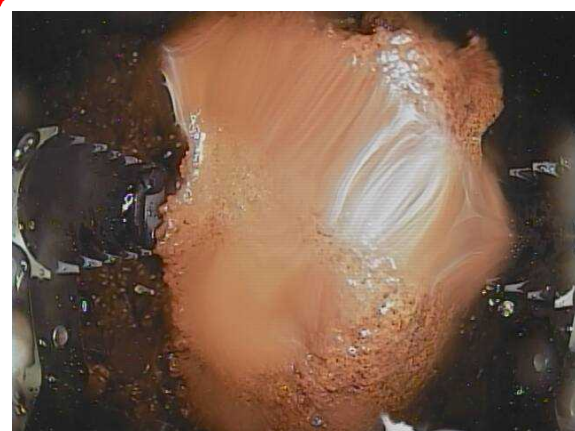
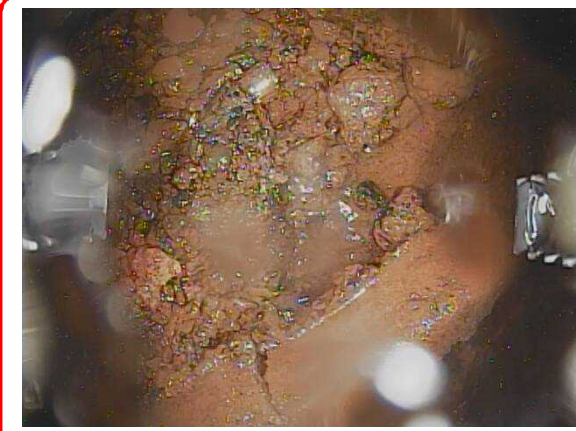
Before touching deposits

During touching deposits

After touching deposits
