Smart Lander for Investigating  
Moon (SLIM)

Results from the Moon Landing

Institute of Space and  
Astronautical Science  
SLIM Project Team  
Project Manager

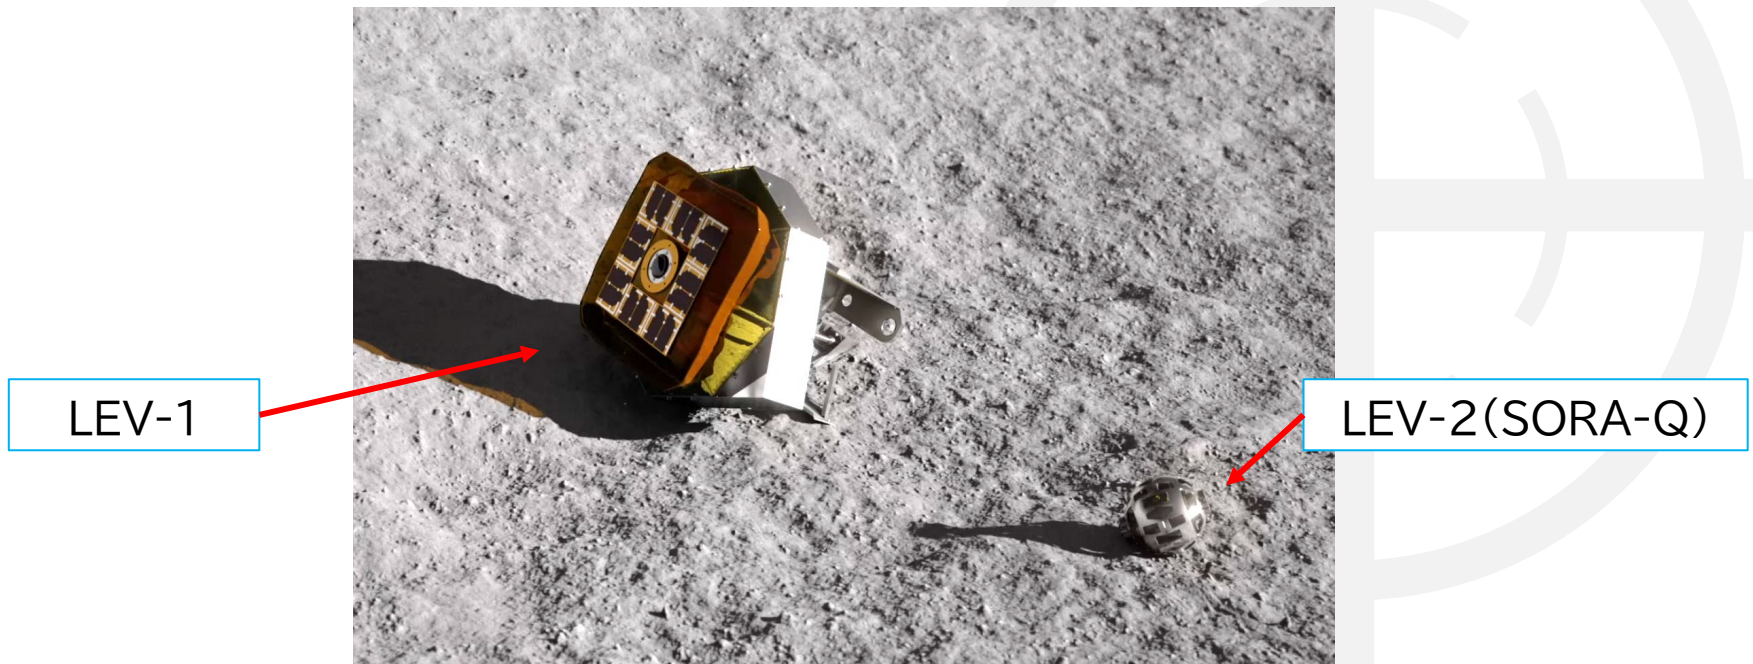
Just before landing, SLIM deployed two ultra-small rovers, LEV-1 and LEV-2 at an altitude of about 5m.

- ▶ LEV-1 and LEV-2 worked on the Moon surface fully autonomously, and in a cooperative manner.
- ▶ LEV-1 carried out experiments of hopping locomotion.
- ▶ LEV-2, also known as “SORA-Q”, succeeded to take a snapshot of SLIM. The image data was transmitted to LEV-1 via Bluetooth, and LEV-1 directly transmitted the data to the Earth (Fully autonomous and cooperated).
- ▶ Note that LEV-1 weighs approx. 2.1kg, and LEV-2 only weighs approx. 0.25kg.  
\*1 ... SORA-Q was developed by JAXA/TOMY Company/Sony/Doshisha Univ.

Artist image of the ultra-small rovers (LEV-1, LEV-2) on the moon

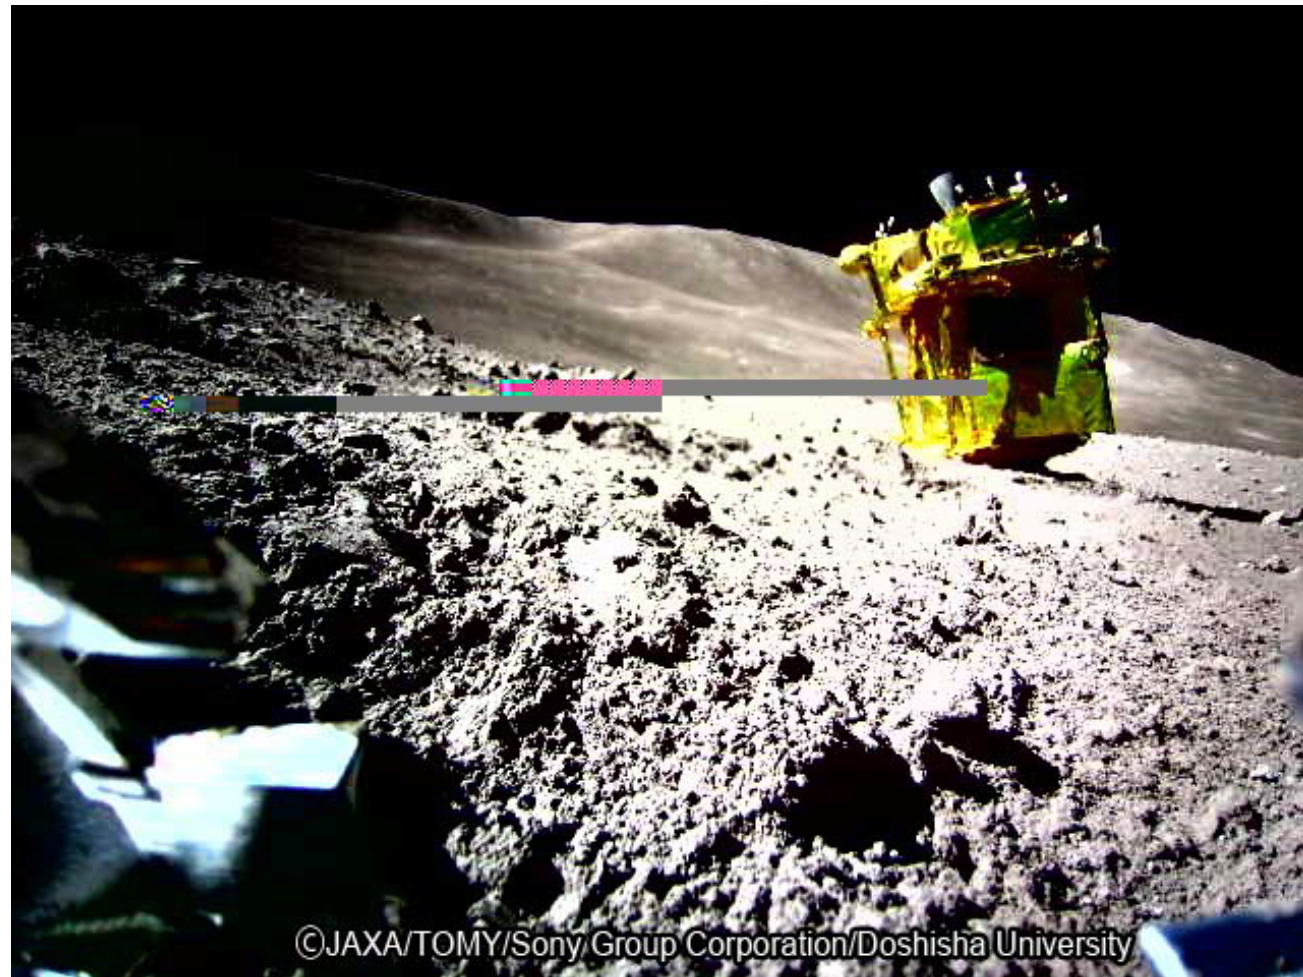
Captured by LEV-2's front camera, then transmitted to the Earth by LEV-1.

- ▶ LEV-2 selected “the best shot”, which effectively captured SLIM and its vicinity, through several taken images.
- ▶ Then sent the image to LEV-1 via Bluetooth, and LEV-1 sent it to the Earth directly.
- ▶ NO ground support for these behavior. It was fully autonomous.
- ▶ Note that again, LEV-1 weighs approx. 2.1kg and achieved direct transmission to the Earth. LEV-2 provided us this impressive photo without any ground support, although only weighs approx. 0.25kg.

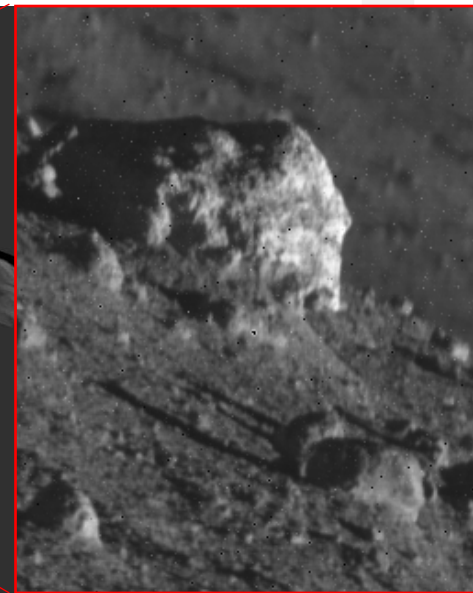
- ▶ Left photo is the 10 target rocks in the 10-band spectroscopic observation after the power restoration. Due to the change of solar illumination conditions, target rocks are selected again after the restoration.
- ▶ Right photo is the detailed image with 1-band ( $1.65\mu\text{m}$ ) on “AKITAINU”.

Automatically focused with MBC, and as a result, the distance is estimated to be about 18m, and the size of AKITAINU is estimated to be about 63cm in width.
