Current status of Fukushima Daiichi NPS

- Efforts for Decommissioning and Contaminated Water Management -

Agency for Natural Resources and Energy, METI

March , 2017

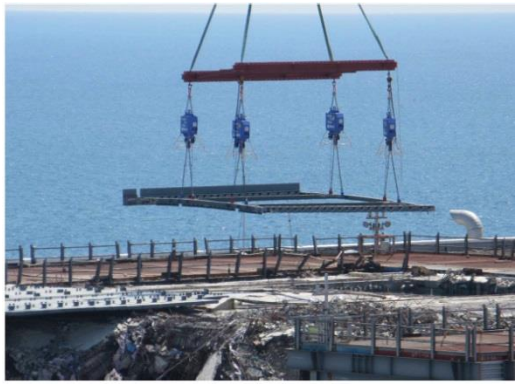
Unit 3

✓ Hydrogen explosion
✓ Core melt

- In December 2016, installing shields on the operating floor was completed.
- In January 2017, installing a Fuel-Handling Machine was started.

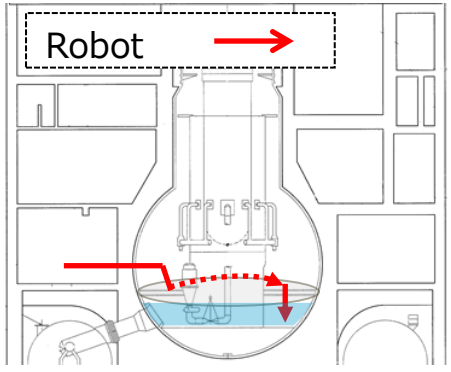
Unit 1

②Inside of the PCV（Apr. 2015）

The investigation will be implement in FY 2016

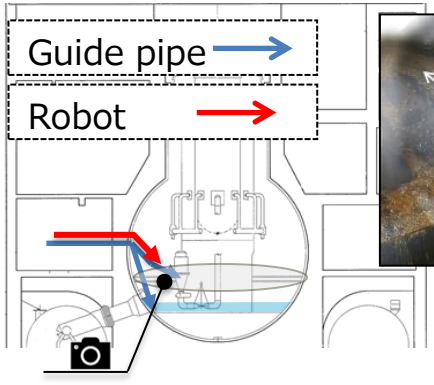
Unit 2

Inside of the PCV（Jan. 2017）

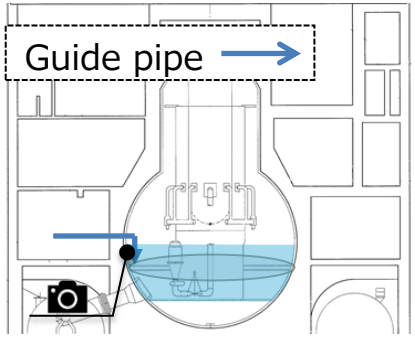
A structure inside of the PCV (Oct. 2015）

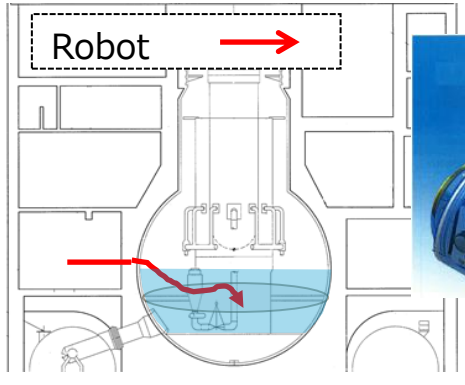
Unit 3

Robot in water

The investigation will be implement in early FY 2017

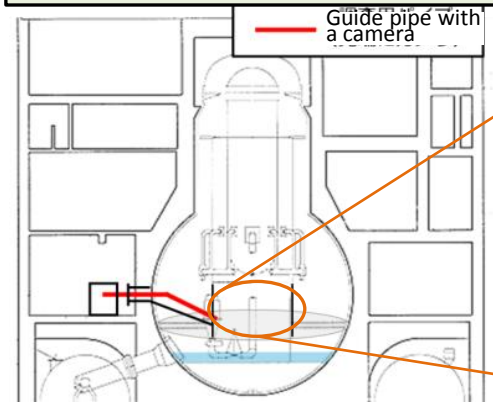
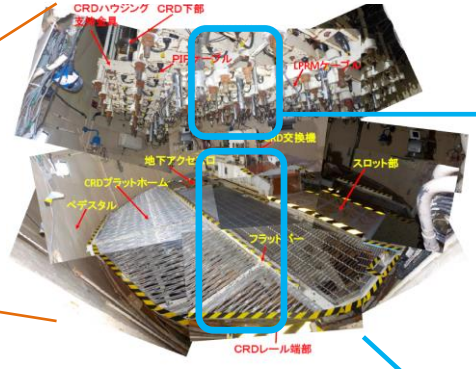
Camera investigation(26th Jan. and 30th Jan.)

◇ To identify the status inside the unit PCV, a camera and a robot were inserted close to the PRV by remote control from 26th January to 16th February.

◇ From the result of this investigation, fallen scaffold below the RPV and the status of deposits were identified directly for the first time. In the PCV, many images were taken. Also, the actual measurement of radiation and temperature were implemented. Effort toward the decommissioning of Unit 2 is progressing steadily.

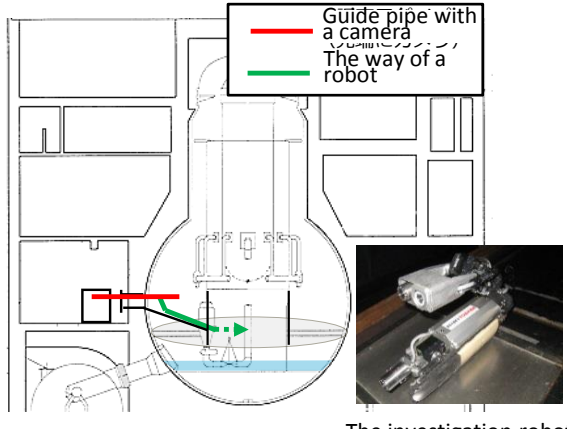
Robot investigation(16th Feb.)

The status below RPV were identified for the first time

No massive damage of facilities below PRV

Fallen scaffold

Radiation dose：Approx. 210 Sievert per hour*

Temperature ：Approx. 16.5 degree**

It is almost the same temperature as one by a constantly monitored thermometer (18.7 degree). **There is no abnormality in the cold shutdown condition.

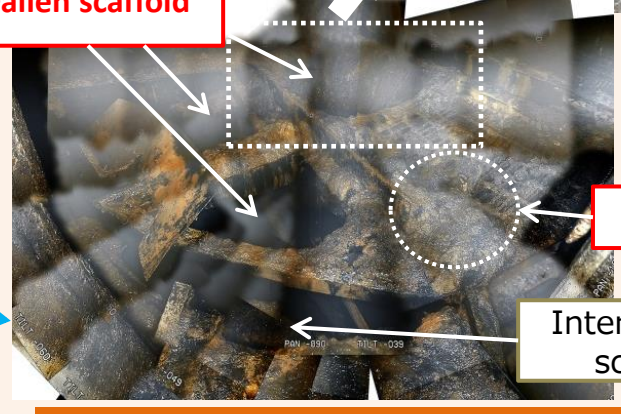
Success of the actual measurement

*This radiation dose is inside of the PCV shielded by thick steel vessel, and concrete. The radiation dose outside of the PCV is approx. 5 to 6 mSv/h. There was and will be no effect by the radioactive material to the outside the PCV.

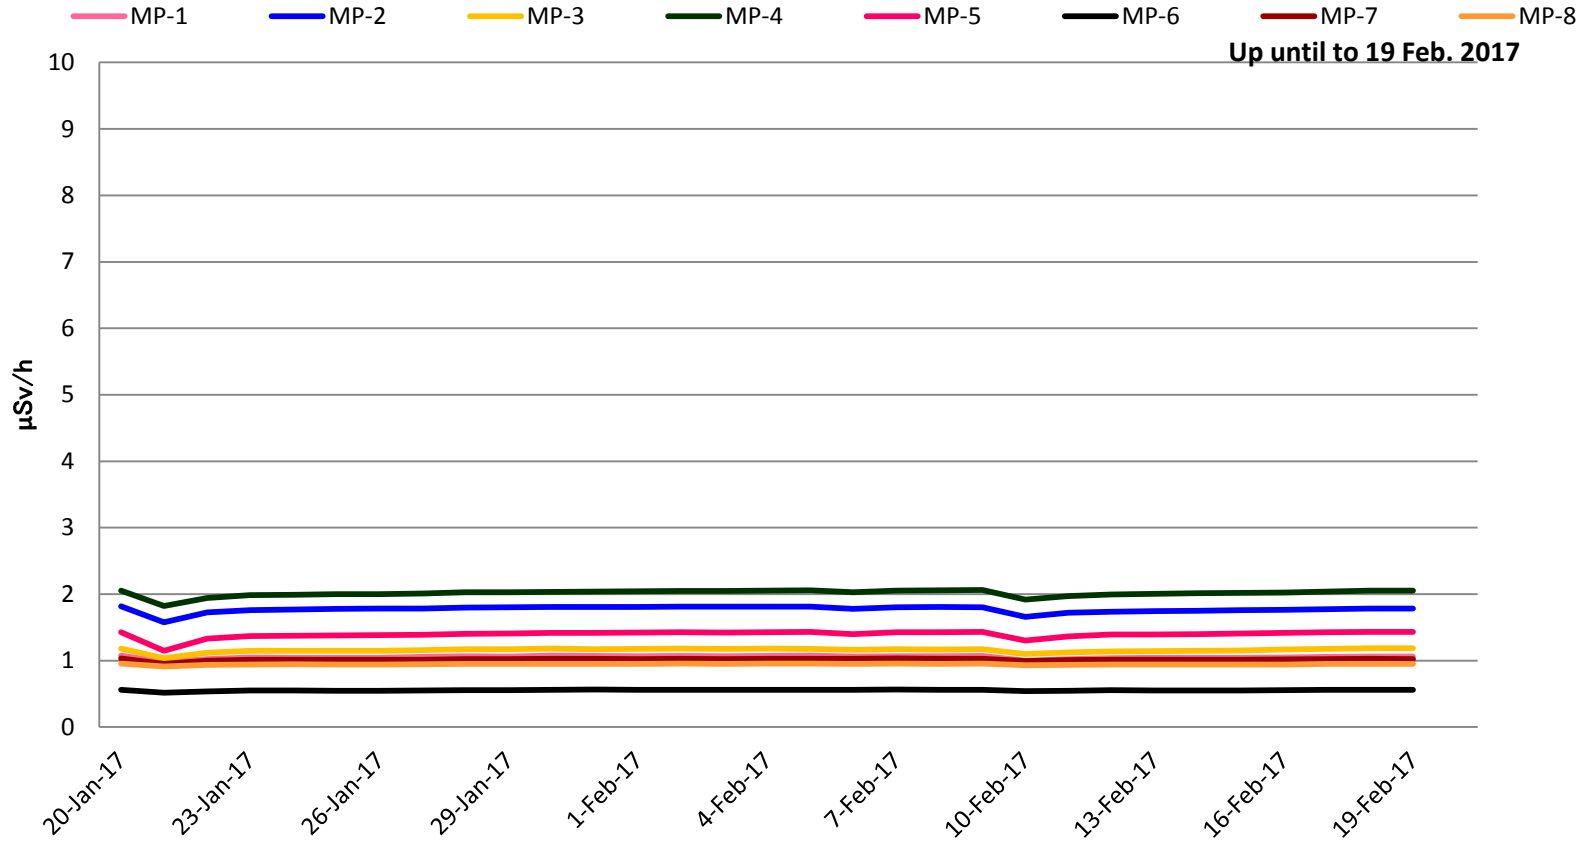
Change of radiation dose at the site boundaries of Fukushima Daiichi NPS

- The result of this investigation does not mean that some new phenomenon inside the PCV has occurred.
- The inside of the PCV is shielded by thick steel vessel, concrete and zinc-plate inside the building and the gas inside PCV are controlled well.
- The status inside the PCV is still stable and there are no changes in radiation levels at the site boundaries of Fukushima Daiichi NPS. Through this investigation, there was and will be no effect by the radioactive material to the outside the PCV.
