Current status of Fukushima Daiichi NPS

**Efforts for Decommissioning and Contaminated Water
Management**

**Agency for Natural Resources and Energy, METI
March, 2018**

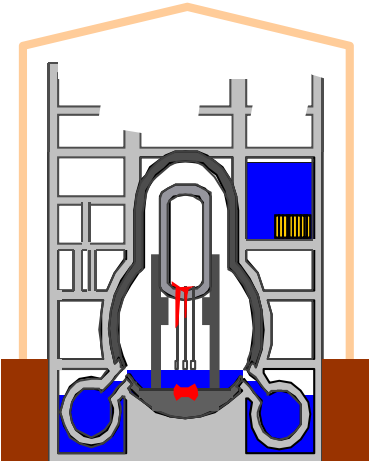
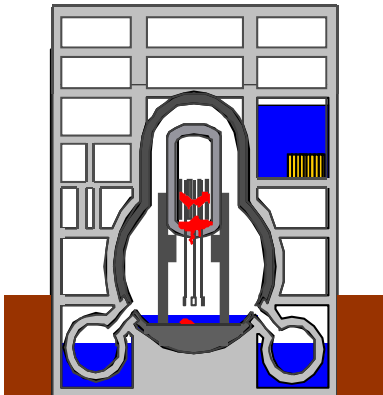
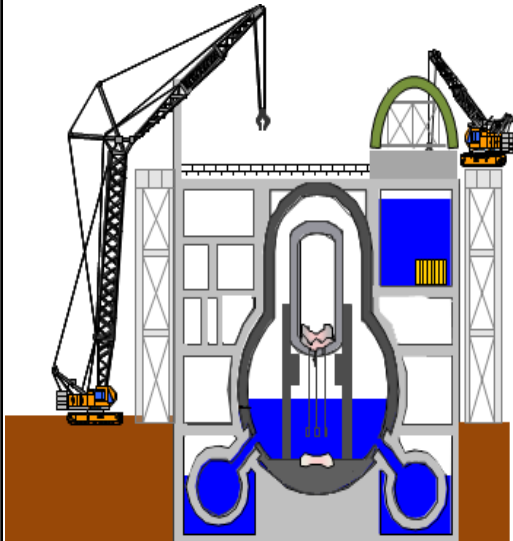
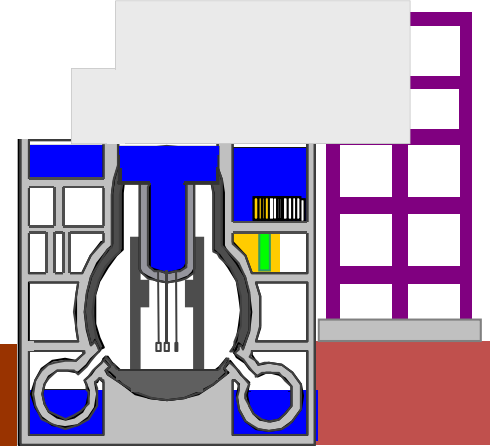
Summary of Fukushima Daiichi NPS Accident - The Damage of each Unit

Unit 1	Unit 2	Unit 3	Unit 4

Status at the accident	In Operation	In Operation	In Operation	Not in Operation (Under planned outages)
Fuels in SPF	392	615	566	1533
Core melt	<input checked="" type="checkbox"/>	<input checked="" type="checkbox"/>	<input checked="" type="checkbox"/>	
Hydrogen explosion	<input checked="" type="checkbox"/>		<input checked="" type="checkbox"/>	<input checked="" type="checkbox"/>

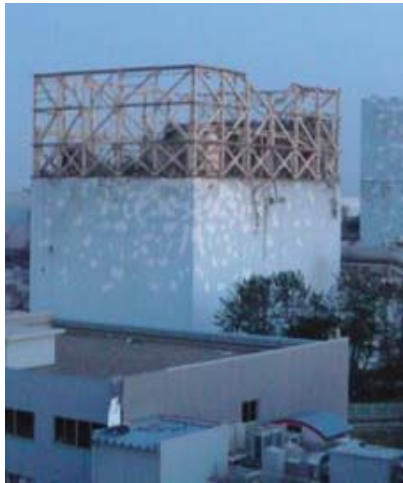
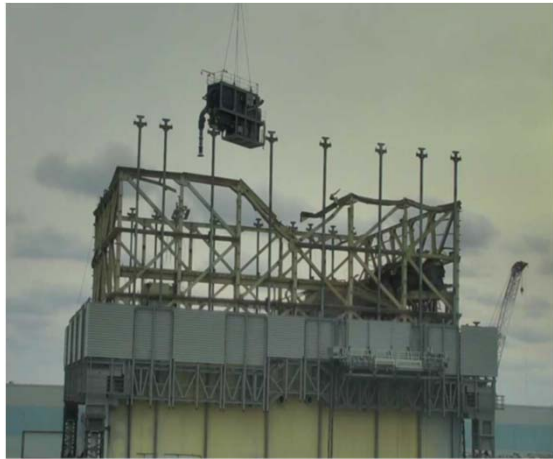
Unit 1

- ✓ Hydrogen explosion
- ✓ Core melt

<At the Time of the Accident>

<Now>

- Installation of windbreak fences to further reduce dust scattering during rubble removal from the operating floor was completed in December 2017. And the removal of the rubble on the operating floor started from January 2018

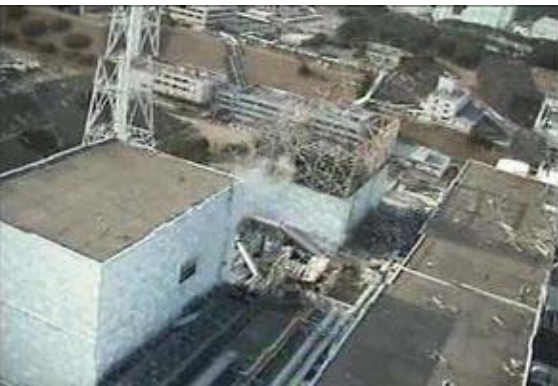
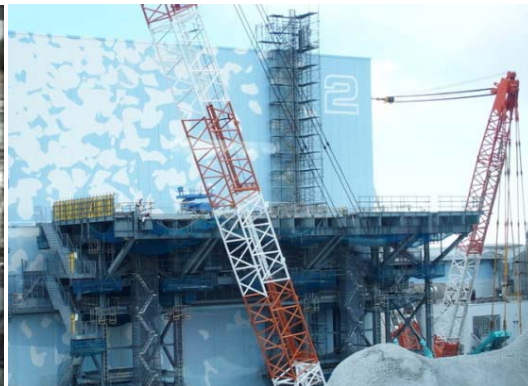
Unit 2

- No hydrogen explosion
- ✓ Core melt

<At the Time of the Accident>

<Now>

- Currently, TEPCO is proceeding with preparation work, such as removal of rubble around the reactor building and building scaffolding.

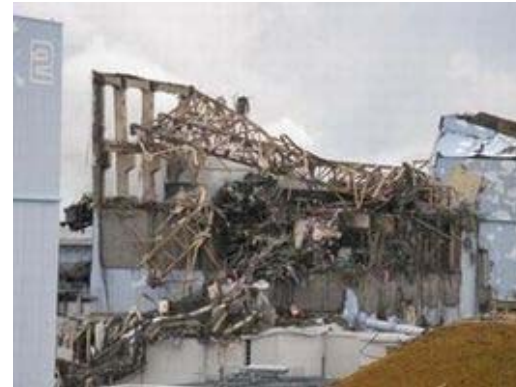
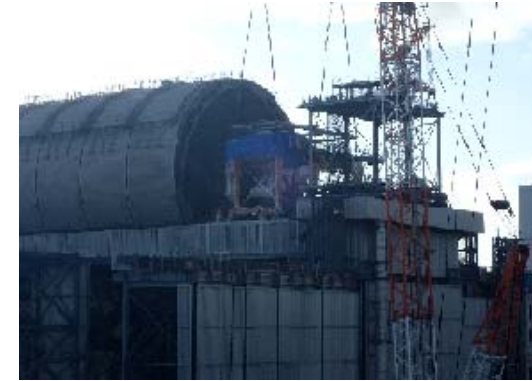
Unit 3

- ✓ Hydrogen explosion
- ✓ Core melt

<At the Time of the Accident>

<Now>

- An equipment to cover the upper part of the building as well as a crane has been installed since August 2017 to start removing spent fuel from the pool in the middle of the 2018 fiscal year.

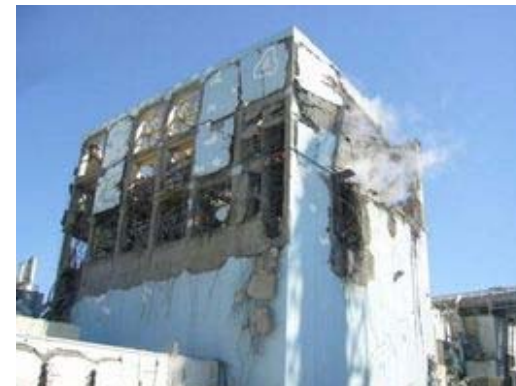
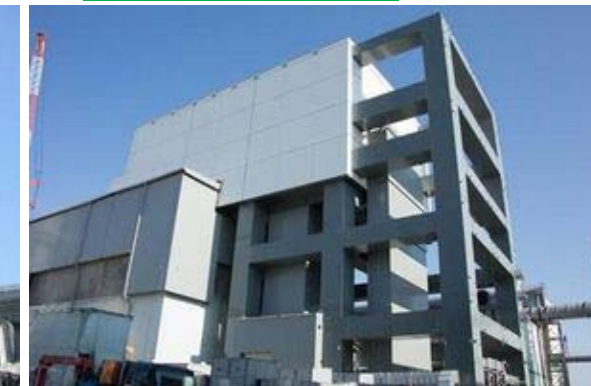
- ✓ Hydrogen explosion
- No core melt

<At the Time of the Accident>

<Now>

- On December 22, 2014, all (1533) fuel removal from Unit 4 SFP was completed.

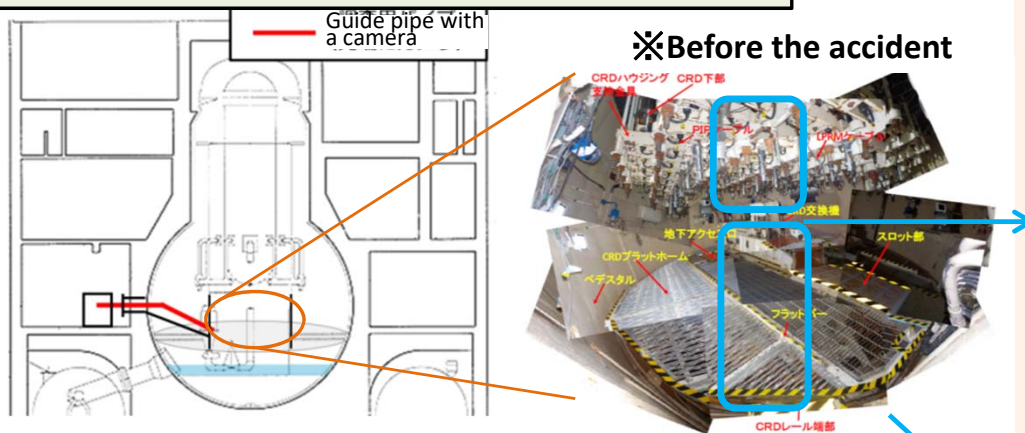
Camera investigation(26th Jan. and 30th Jan. 2017)

- To determine the status inside the Unit 2 PCV, a camera and a robot were inserted close to the RPV by remote control from 26th January to 16th February.
- From the results of this investigation, the fallen scaffold below the RPV and the status of deposits were identified directly for the first time. In the PCV, many images were taken. Also, actual measurement of radiation and temperature were implemented. Effort toward the decommissioning of Unit 2 is progressing steadily.
- Through this investigation, there was and will be no effect by the radioactive material to the outside the PCV.

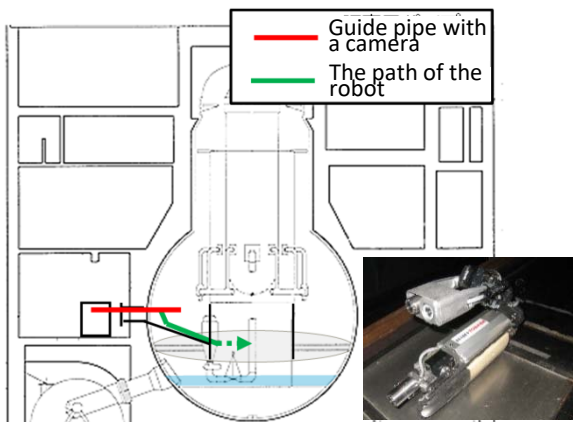
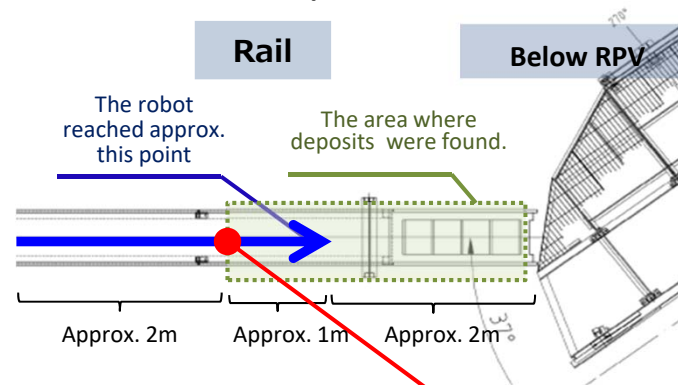
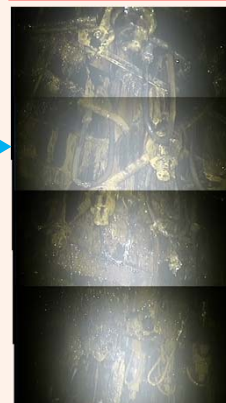
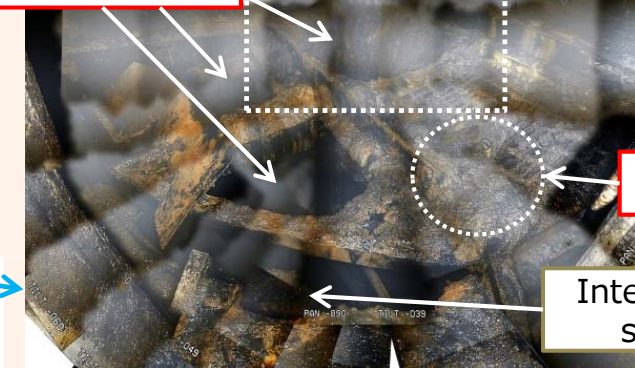
Robot investigation(16th Feb. 2017)

The investigation robot

※Overhead view : the path of the robot

The status below RPV were identified for the first time

No massive damage of facilities below RPV

Fallen scaffold

Deposits

Interspace of scaffold

Success of the actual measurement

Radiation dose : Approx. 70 Sievert per hour*

*This radiation dose is inside of the PCV shielded by the thick steel vessel, and concrete. The radiation dose outside of the PCV is approx. 5 to 6 mSv/h. There was and will be no effect of the radioactive material outside the PCV.

Temperature : Approx. 16.5 degrees**

**It is almost the same temperature as that measured by the constantly monitoring thermometer (18.7 degrees). There is no abnormality in the cold shutdown condition.

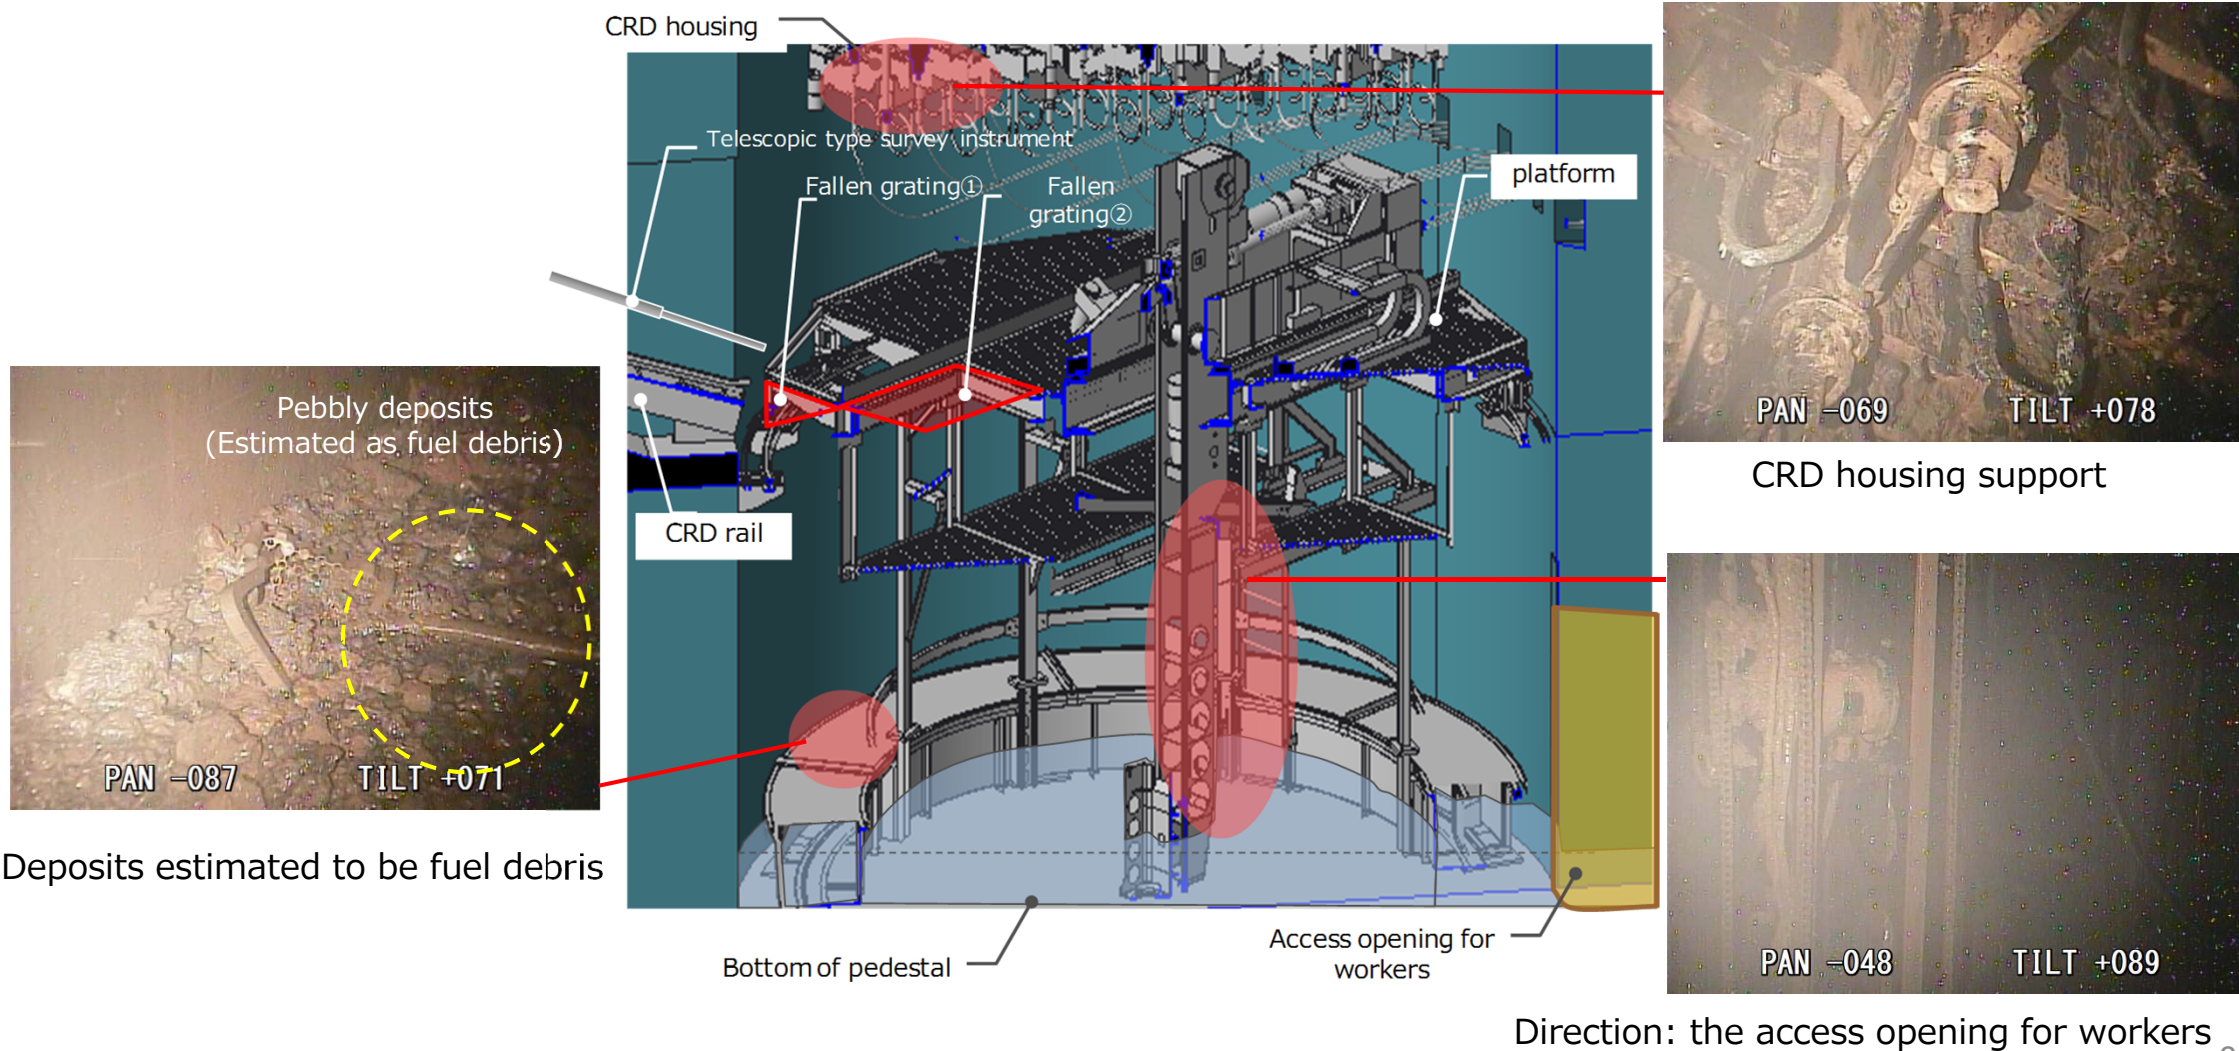
The results of the investigation inside the Unit 2 PCV (January 2018)

- ◇ On January 19, the inside of the Unit 2 PCV was investigated. As a result of it, recording the images were succeeded.
- ◇ Through the image of the camera, the lower part of the lattice-like scaffold just below the pressure vessel was seen. It was confirmed that part of the fuel assembly dropped to the bottom of the containment vessel, and deposits considered to be fuel debris in the RPV. In addition, the dose tended to be lower inside the pedestal than outside the pedestal.
- ◇ from now on, detailed analysis and evaluation of data acquired images and dose will be advanced.

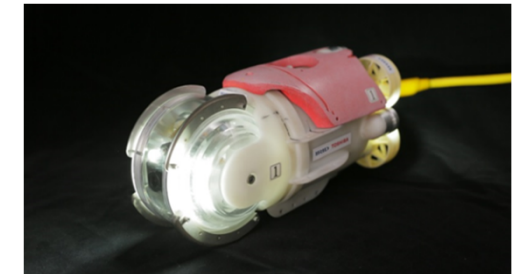
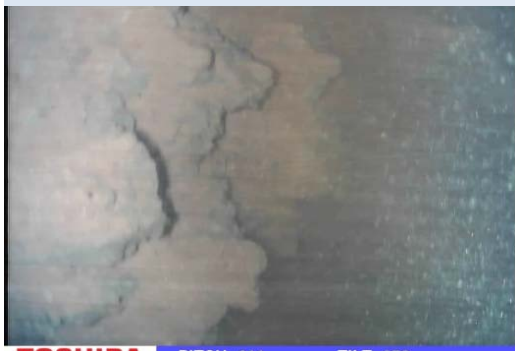
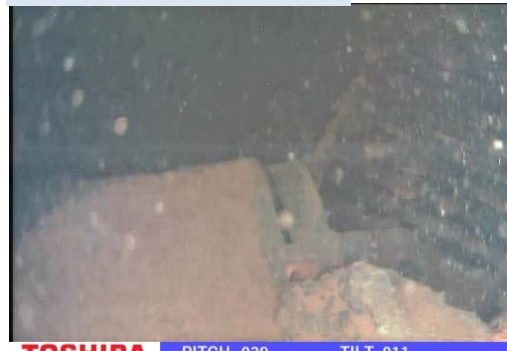
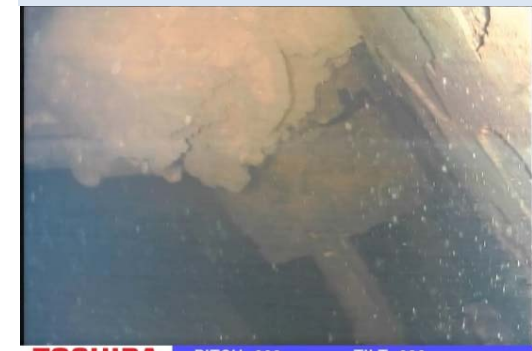
Investigation inside the Unit 3 PCV (July 2017)

- In July 2017, the interior of the PCV was investigated using the underwater ROV (remotely operated underwater vehicle) to inspect the inside of the pedestal.
- The investigation identified several fallen obstacles and deposits, such as seemingly solidified molten materials and grating, inside the pedestal.

Underwater ROV

Lower center in Pedestal

Inside Pedestal

Pedestal

Close to the wall in Pedestal

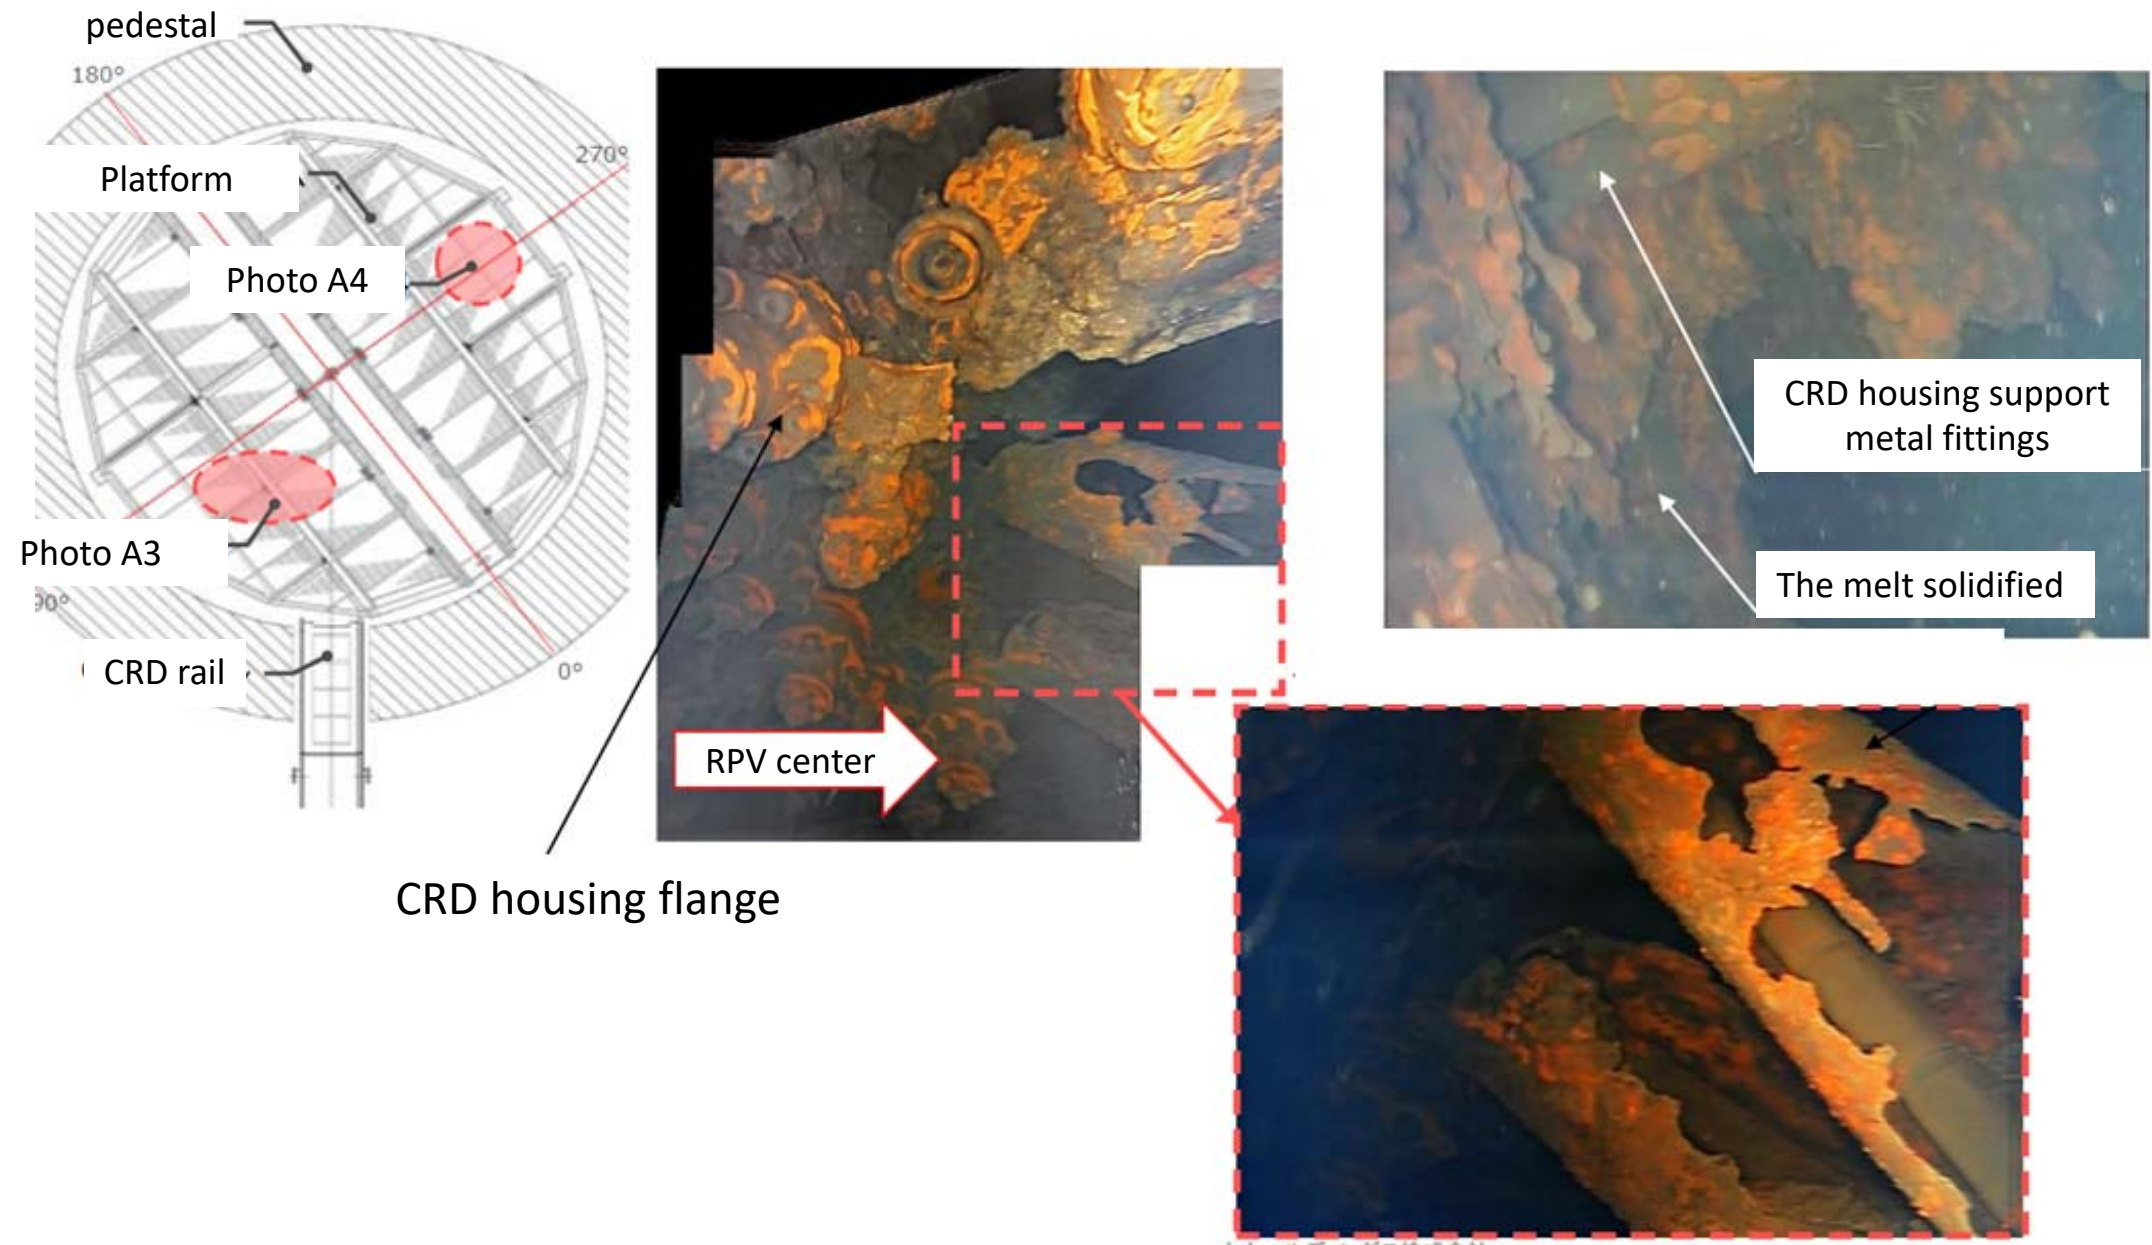
The results of the investigation inside the Unit 3 PCV (November 2017)

- "CR guide pipe" that should be at the lower part of the RPV was at the bottom of the PCV.
- Therefore, there is a possibility that holes of several tens of centimeters in diameter are opened at the bottom of the RPV.

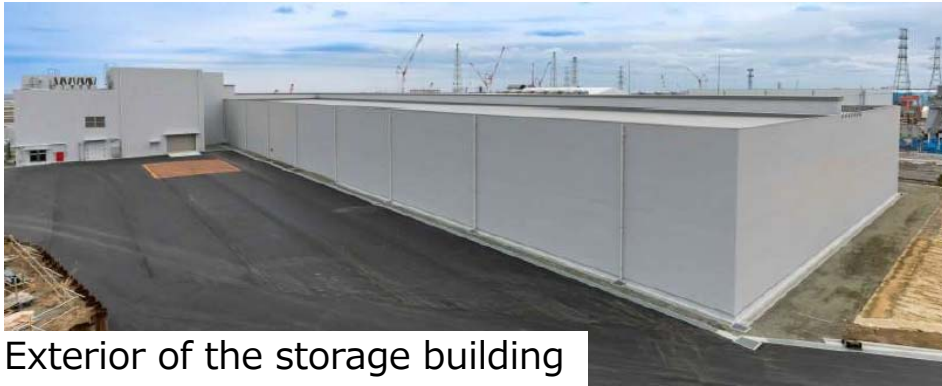
◇ The purpose of setting the ninth tower of solid waste storage is to store debris generated in the decommissioning work and radioactive solid waste stored from before the accident, like the first to eighth buildings installed in the premises.

Exterior of the storage building

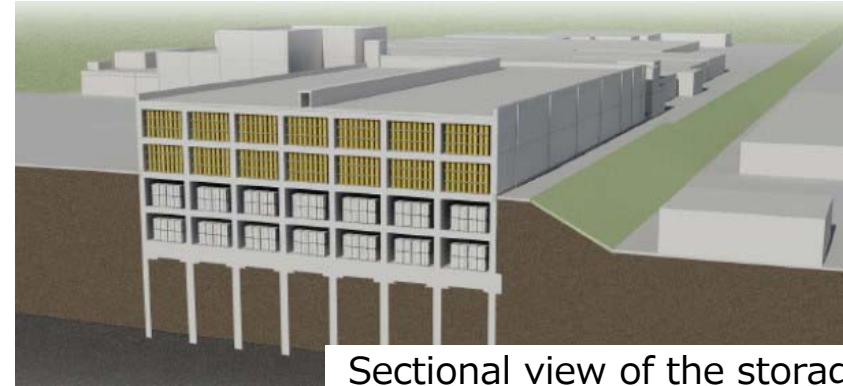
Sectional view of the storage building

The storage capacity: approx. 61,200m³ (corresponding to 200 ℓ × 110,000 cans)

Cf: Total amount of the first to the eighth storage capacities are corresponding to 200 ℓ × 284,500 cans

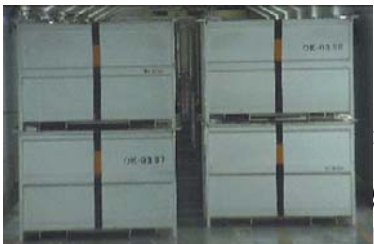
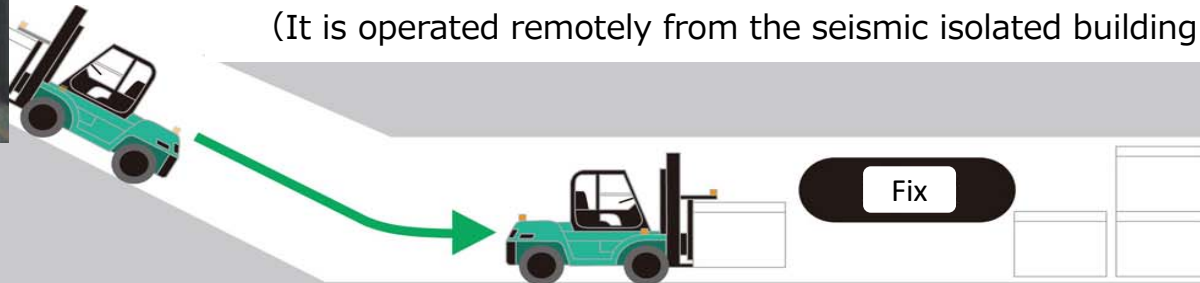
Rectangular containers

● Unattended remote forklift

(It is operated remotely from the seismic isolated building.)
