# **FPCJ Press Briefing**

# Fukushima Daiichi Decontamination and Decommissioning : Current Status and Challenges

Naohiro MASUDA Chief Decommissioning Officer, President of Fukushima Daiichi Decontamination and Decommissioning Engineering Company, Tokyo Electric Power Company Holdings, Inc.

March 2, 2018

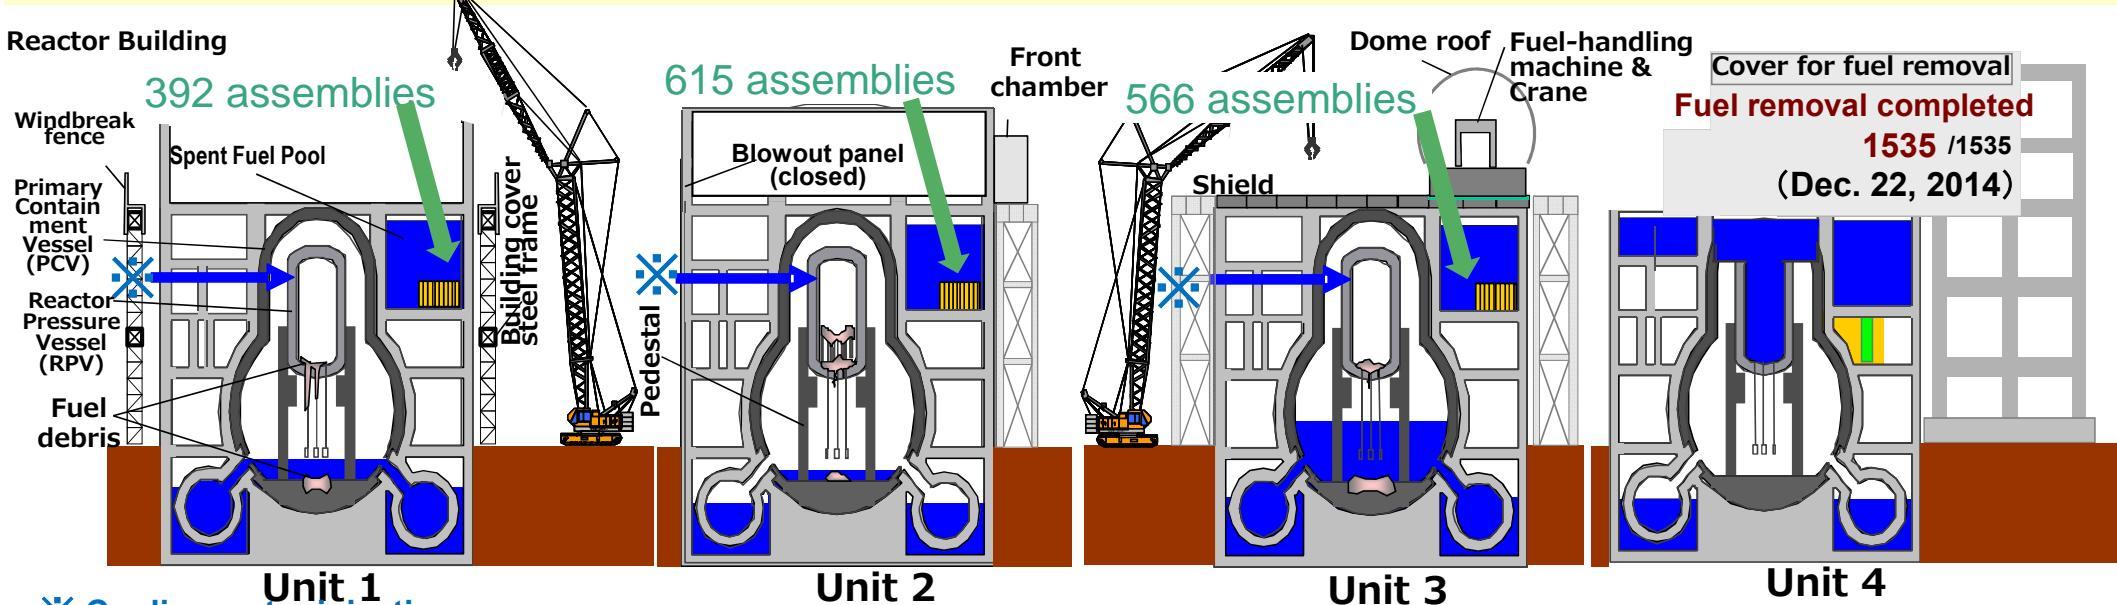
#### (1) State of Units 1~4 **TEPCO**

All reactors are in cold shutdown condition.

Plant parameters including RPV and PCV temperatures are monitored continuously 24 hours/day.

Unit 1 X Cooling water injection

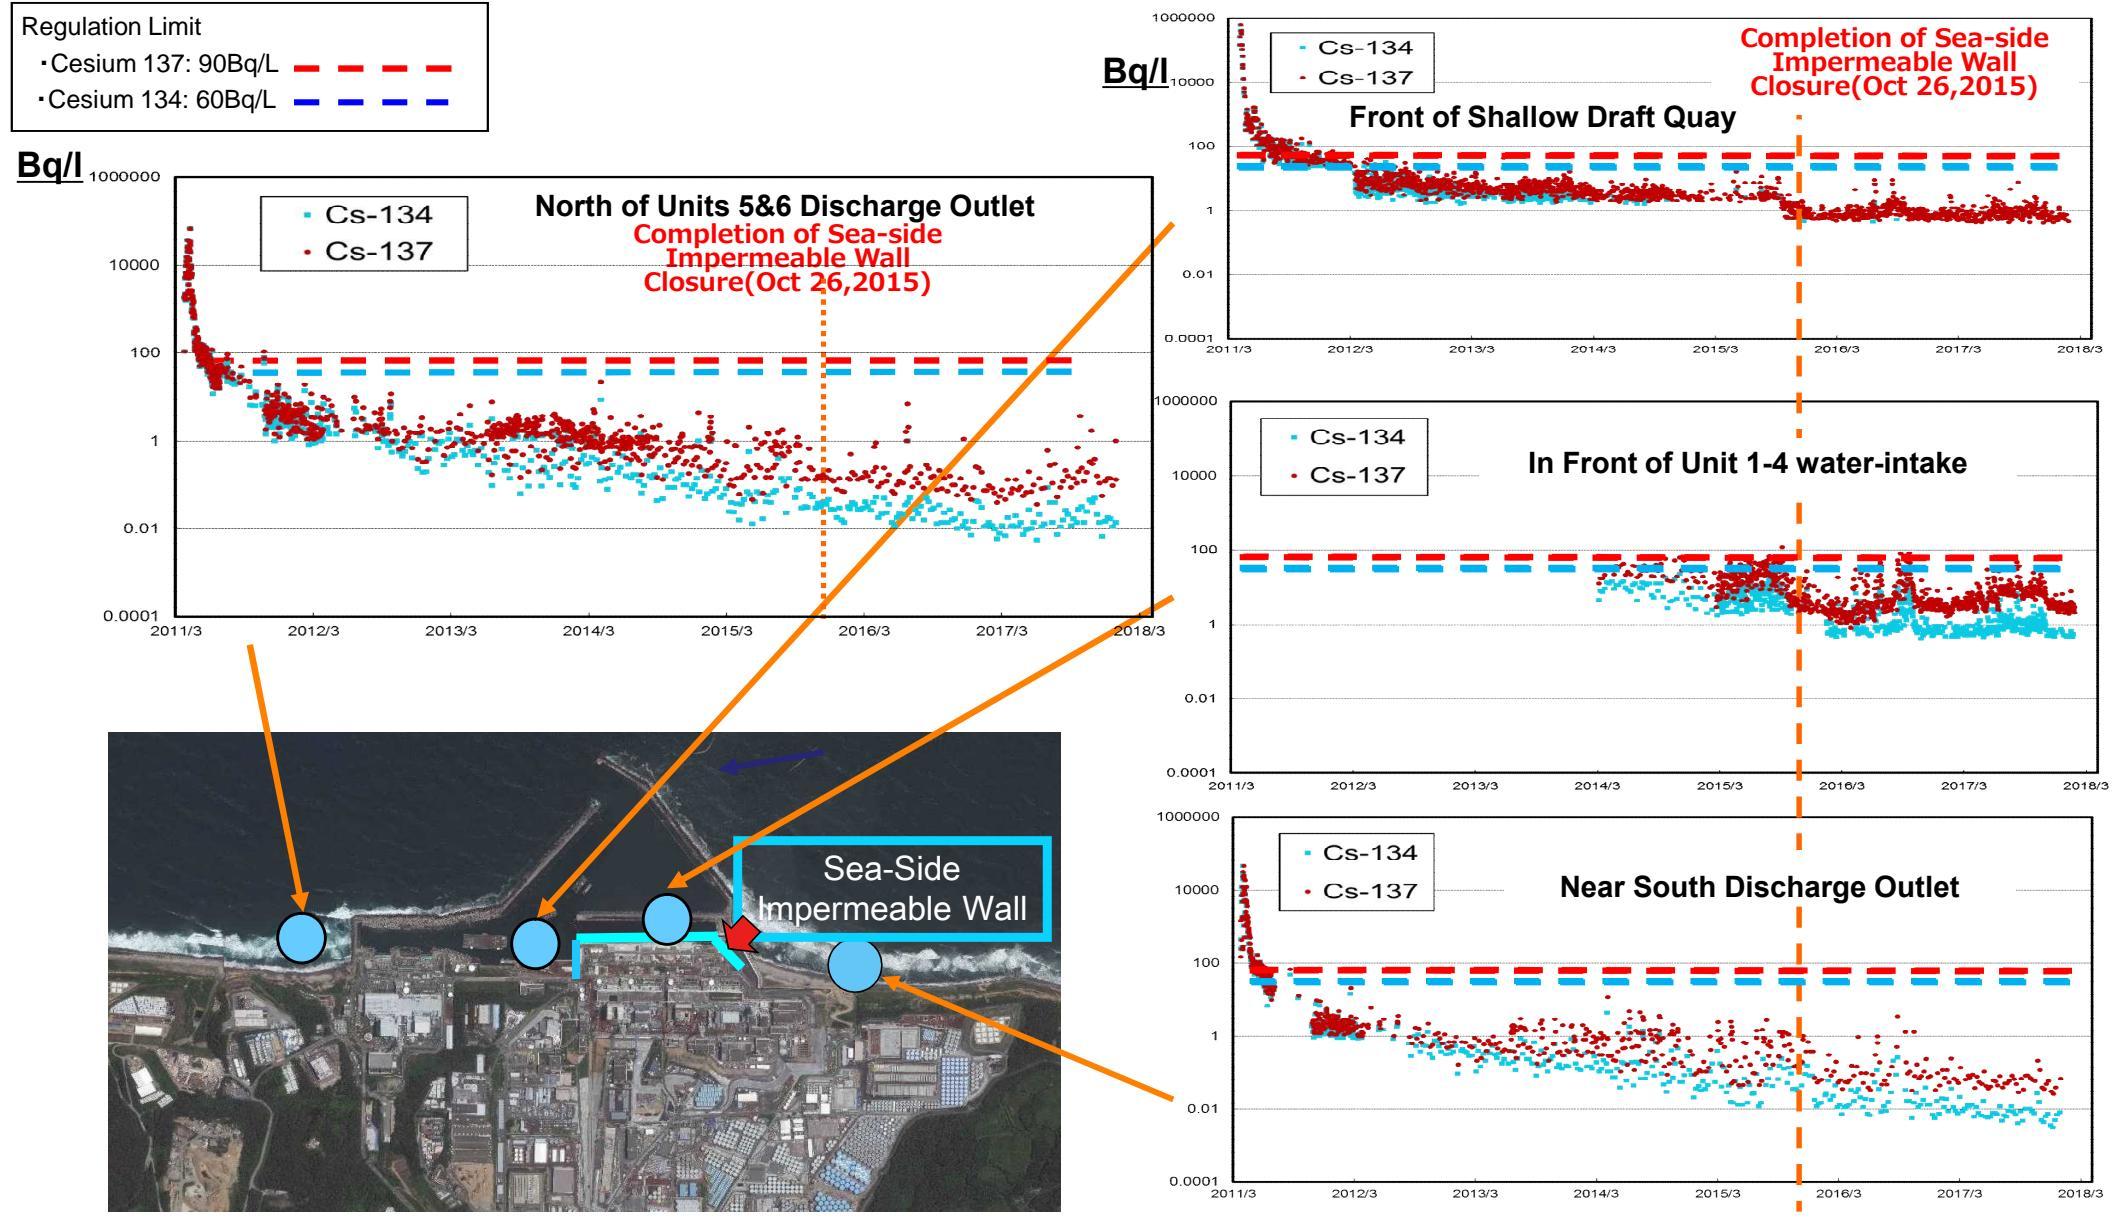
# TEPCO (2) Monitoring Level in the Sea Compared to the situation just after the accident, the current level of radioactivity has been lowered to parts per hundred thousand, to per million.

- The concentrations outside the port are substantially below regulation limits.
- Concentration levels decreased further after closure of the sea-side impermeable wall.

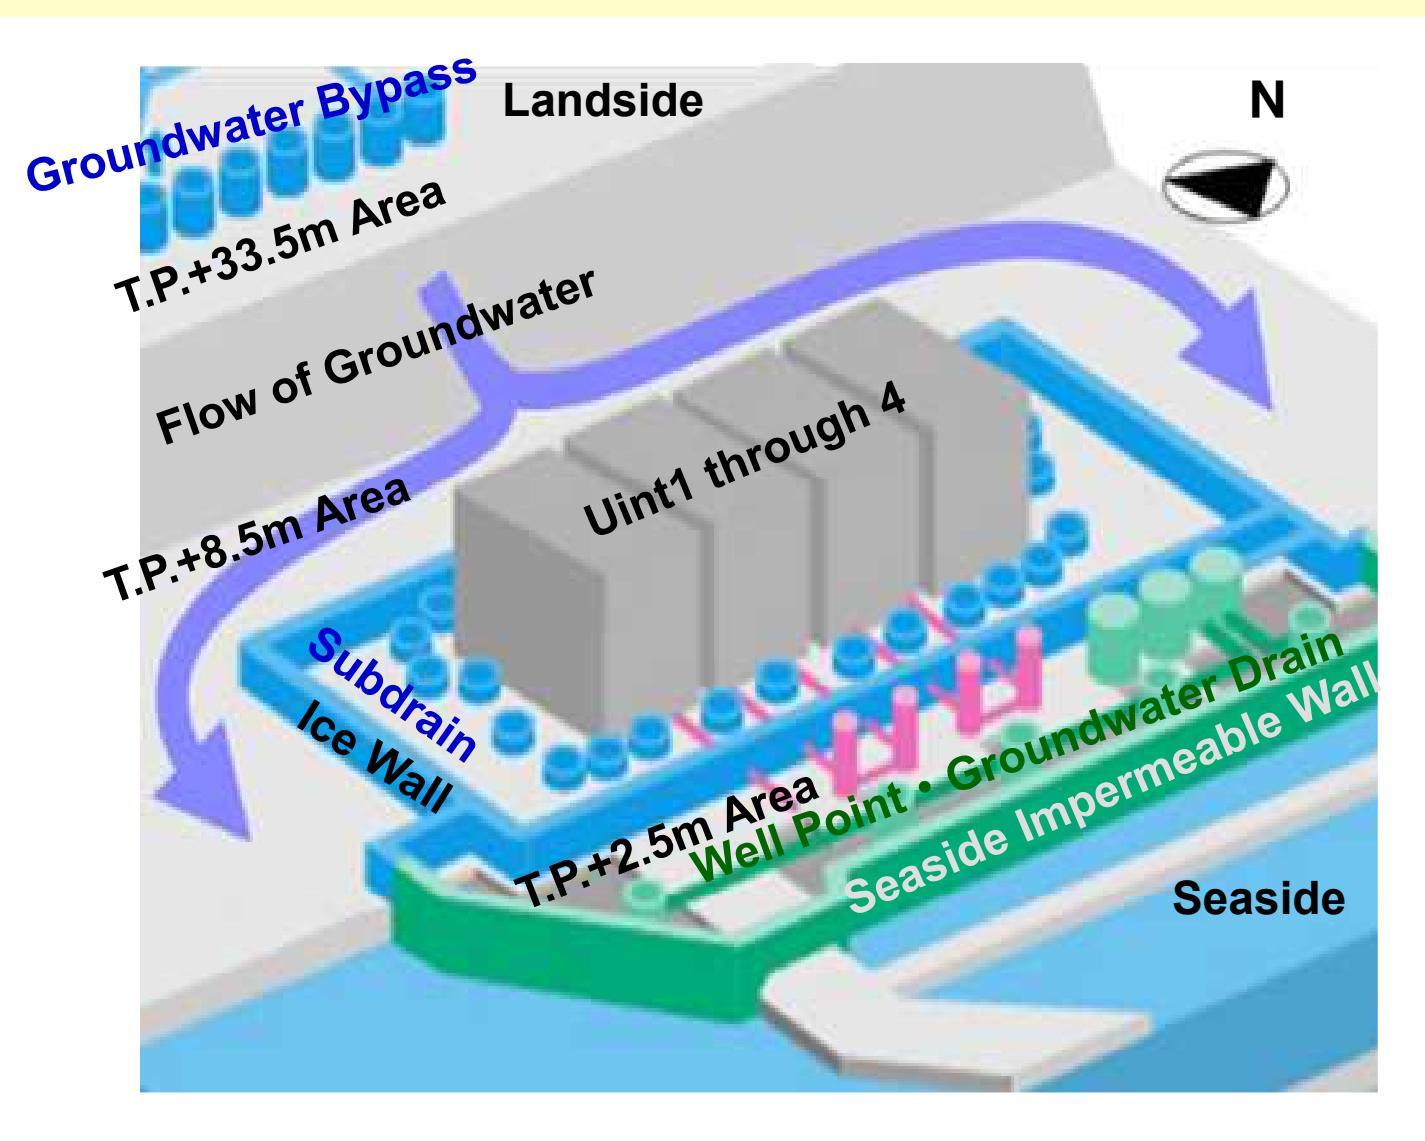
# **TEPCO** (2) Closure of the Ice Wall

Thanks to the closure of the Ice Wall, the groundwater from the landside is dammed up and makes a detour around the buildings, and eventually flows to the seaside.

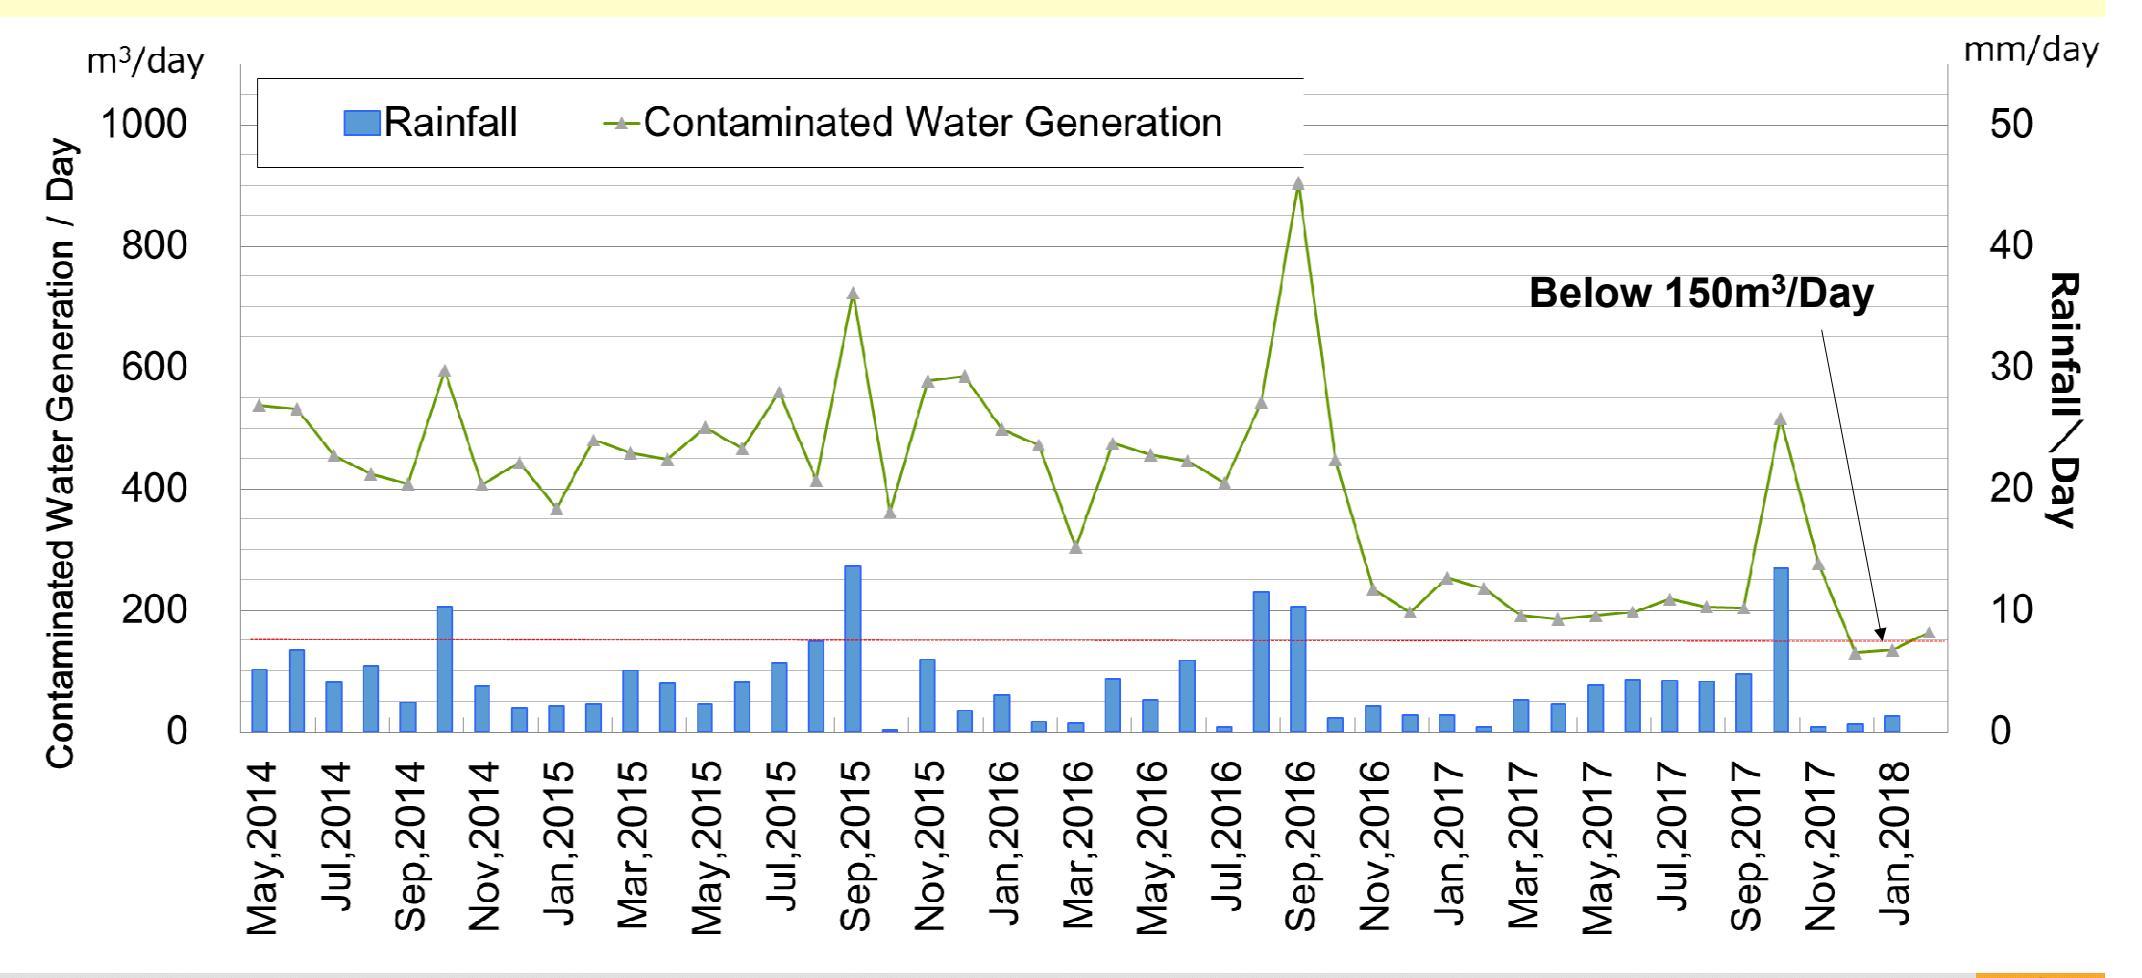
## **TEPCO** (3) Reduction of contaminated water generation

- Generation of the contaminated water originated from rainy and ground water decreased from 490m<sup>3</sup>/Day to 110m<sup>3</sup>/Day (Dec. 2017 to Feb. 2018) after the closure, which is less than one-fourth of the initial amount.
- Generation of the contaminated water totaled 140m<sup>3</sup>/Day if water originated from decommissioning work was included. Even though the record was during the drought season, that amount is below the target value of 150 m<sup>3</sup>/Day set for 2020 in the Mid- and Long-term Roadmap.

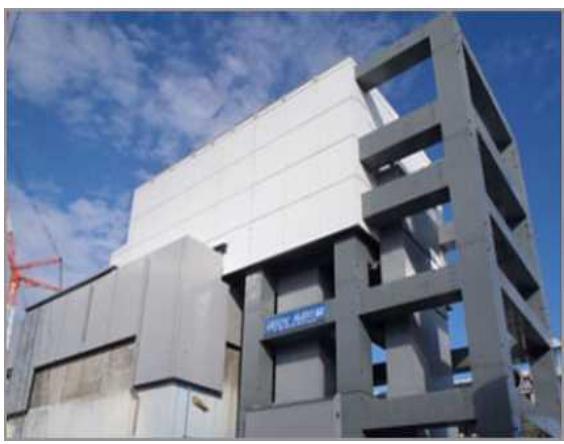
November 12, 2013: Completion of fuel removal facility (The volume of steel used is equivalent to those of Tokyo Tower)

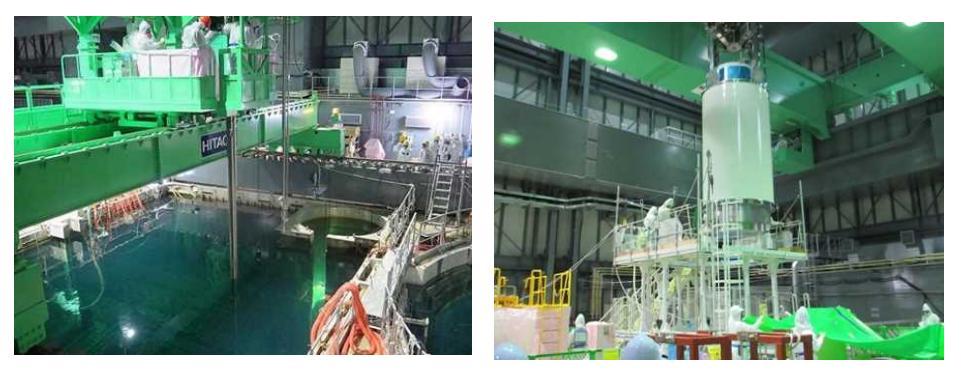
Process of removing fuel rods at SFP Unit 4

Fuel removal was completed on Dec. 22, 2014

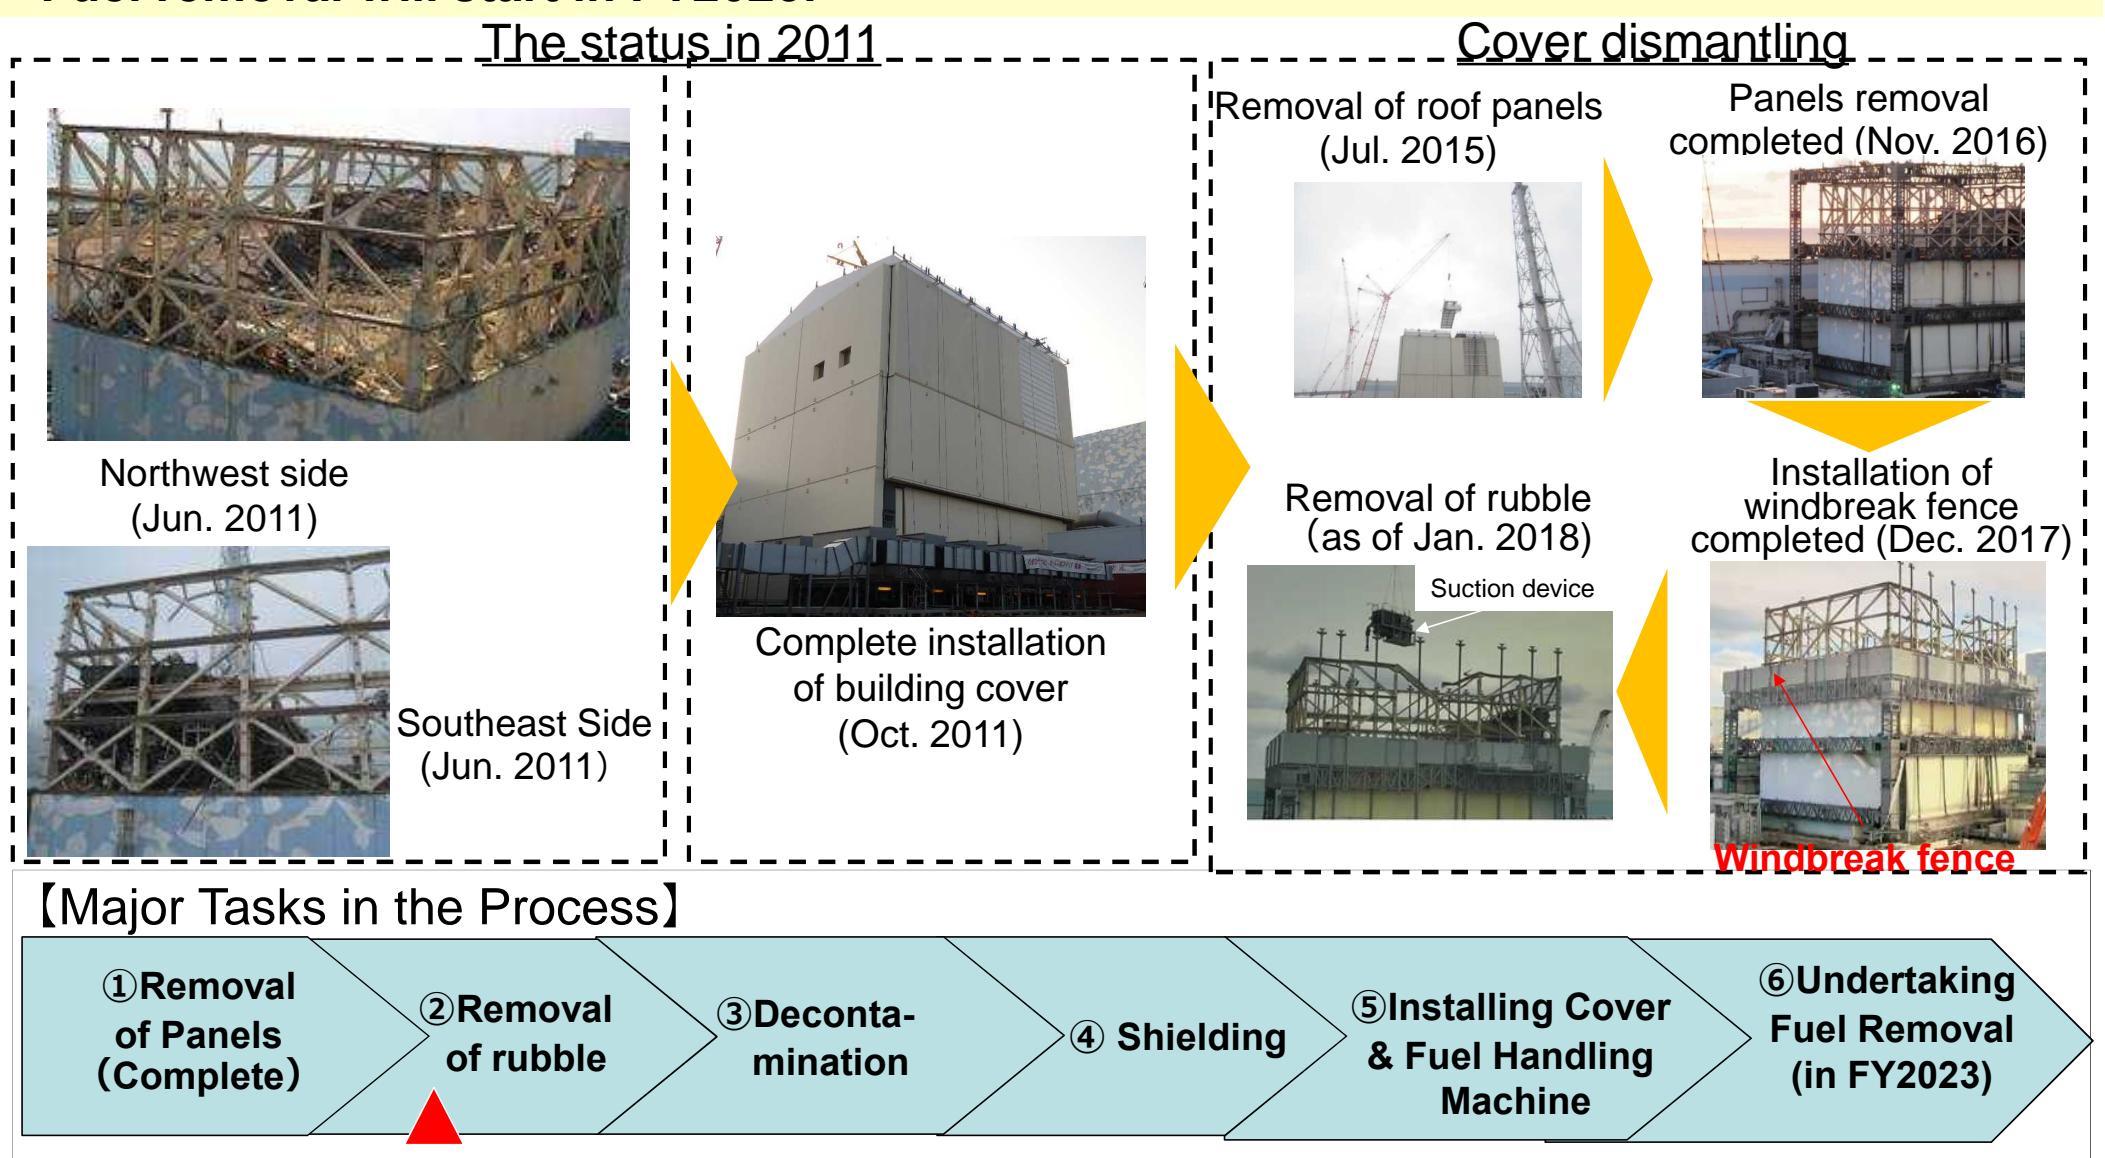
# (3) Fuel Removal from the Spent Fuel Pool (Unit 1)

Building cover was installed in Oct. 2011 to prevent dispersion of radioactive materials. Removal of panels was completed in Nov. 2016. After the installation of a windbreak fence, removal of rubble started in Jan. 2018. Fuel removal will start in FY2023.

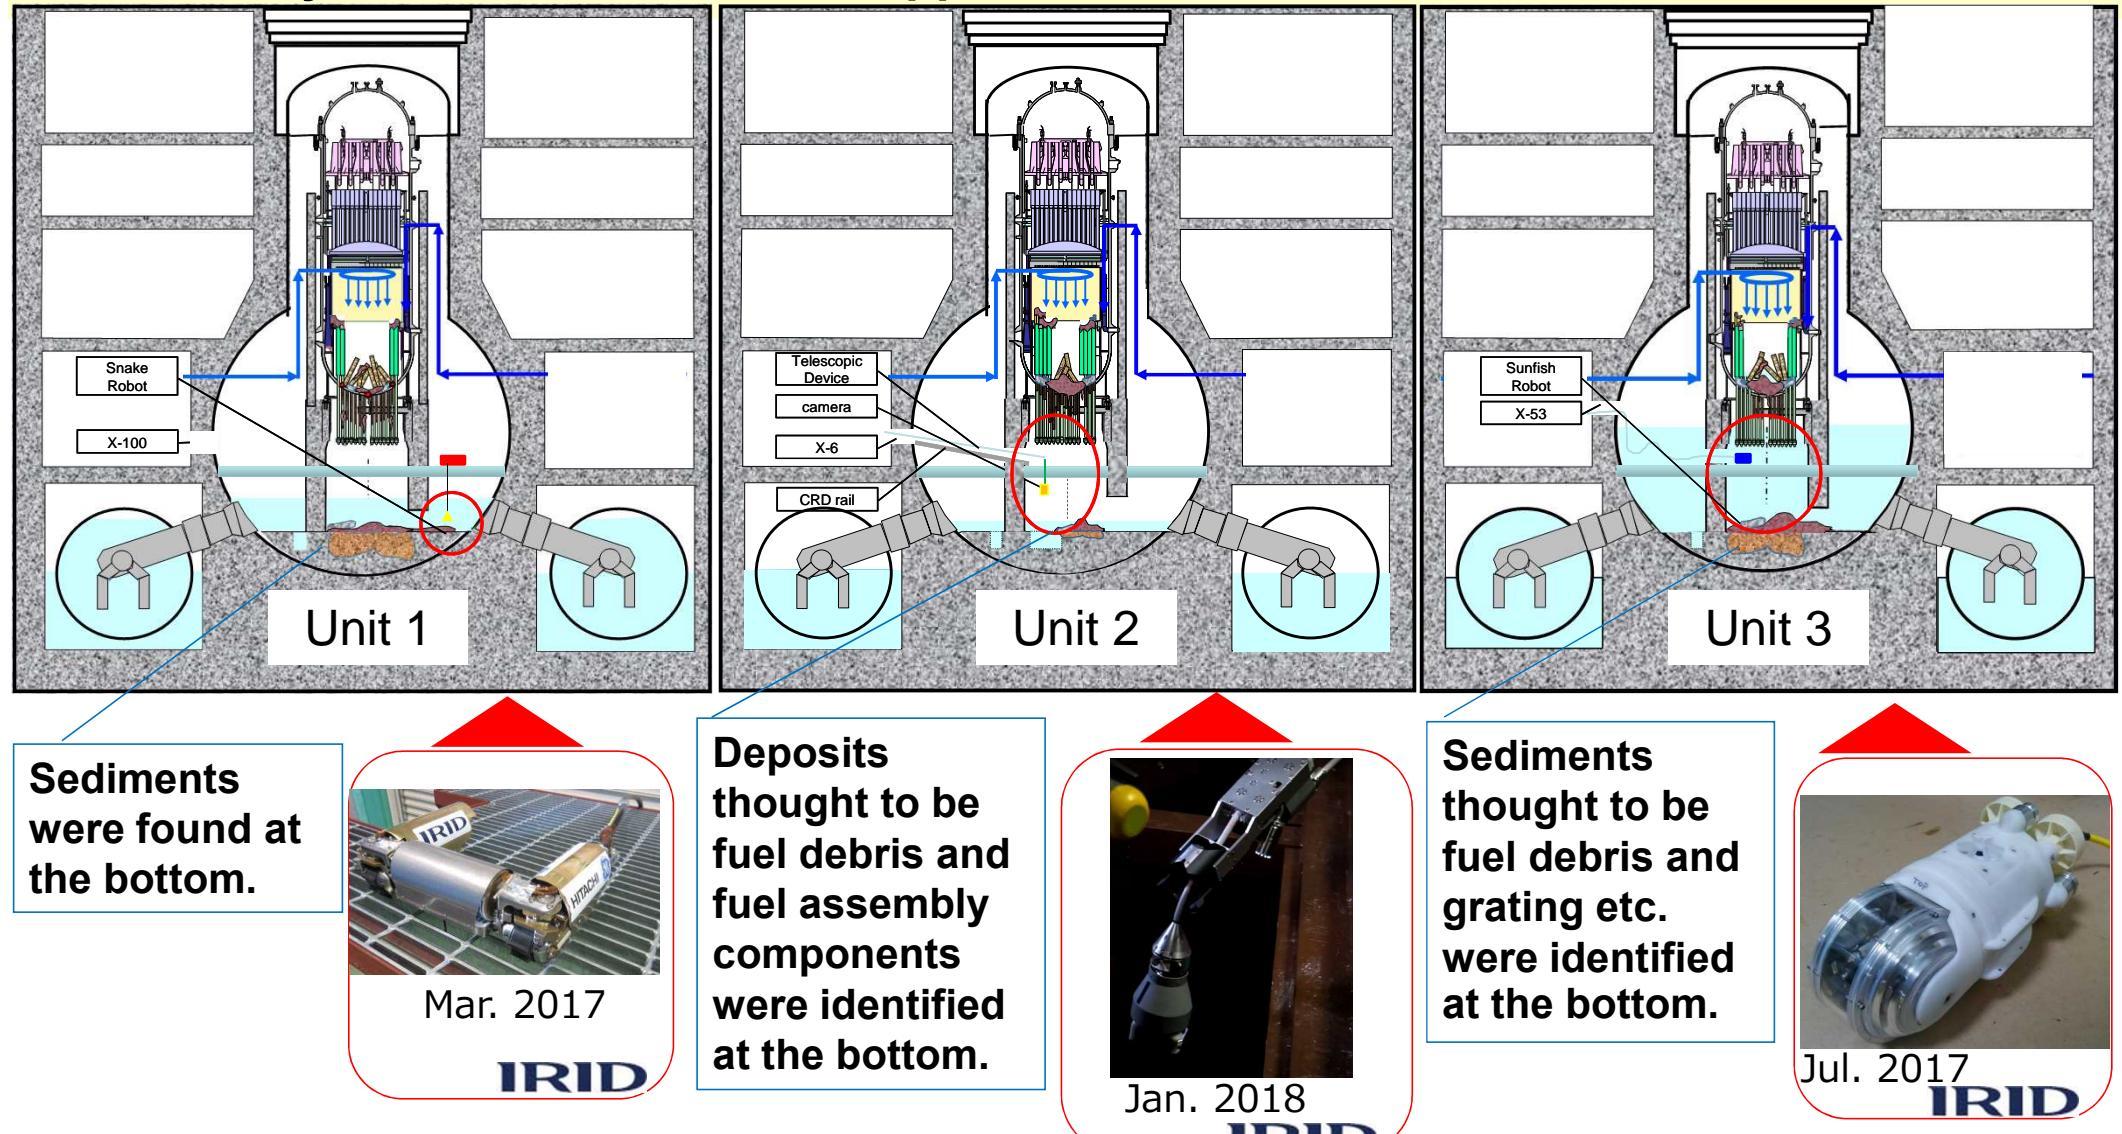
# (1) Assumed Distribution of Fuel Debris

- It is assumed that at Unit 1 and 3, most of fuel debris has dropped to the bottom of PCV.
- It is assumed that at Unit 2, most of fuel debris has remained at the bottom of RPV, while only a small amount has dropped to the bottom of PCV.

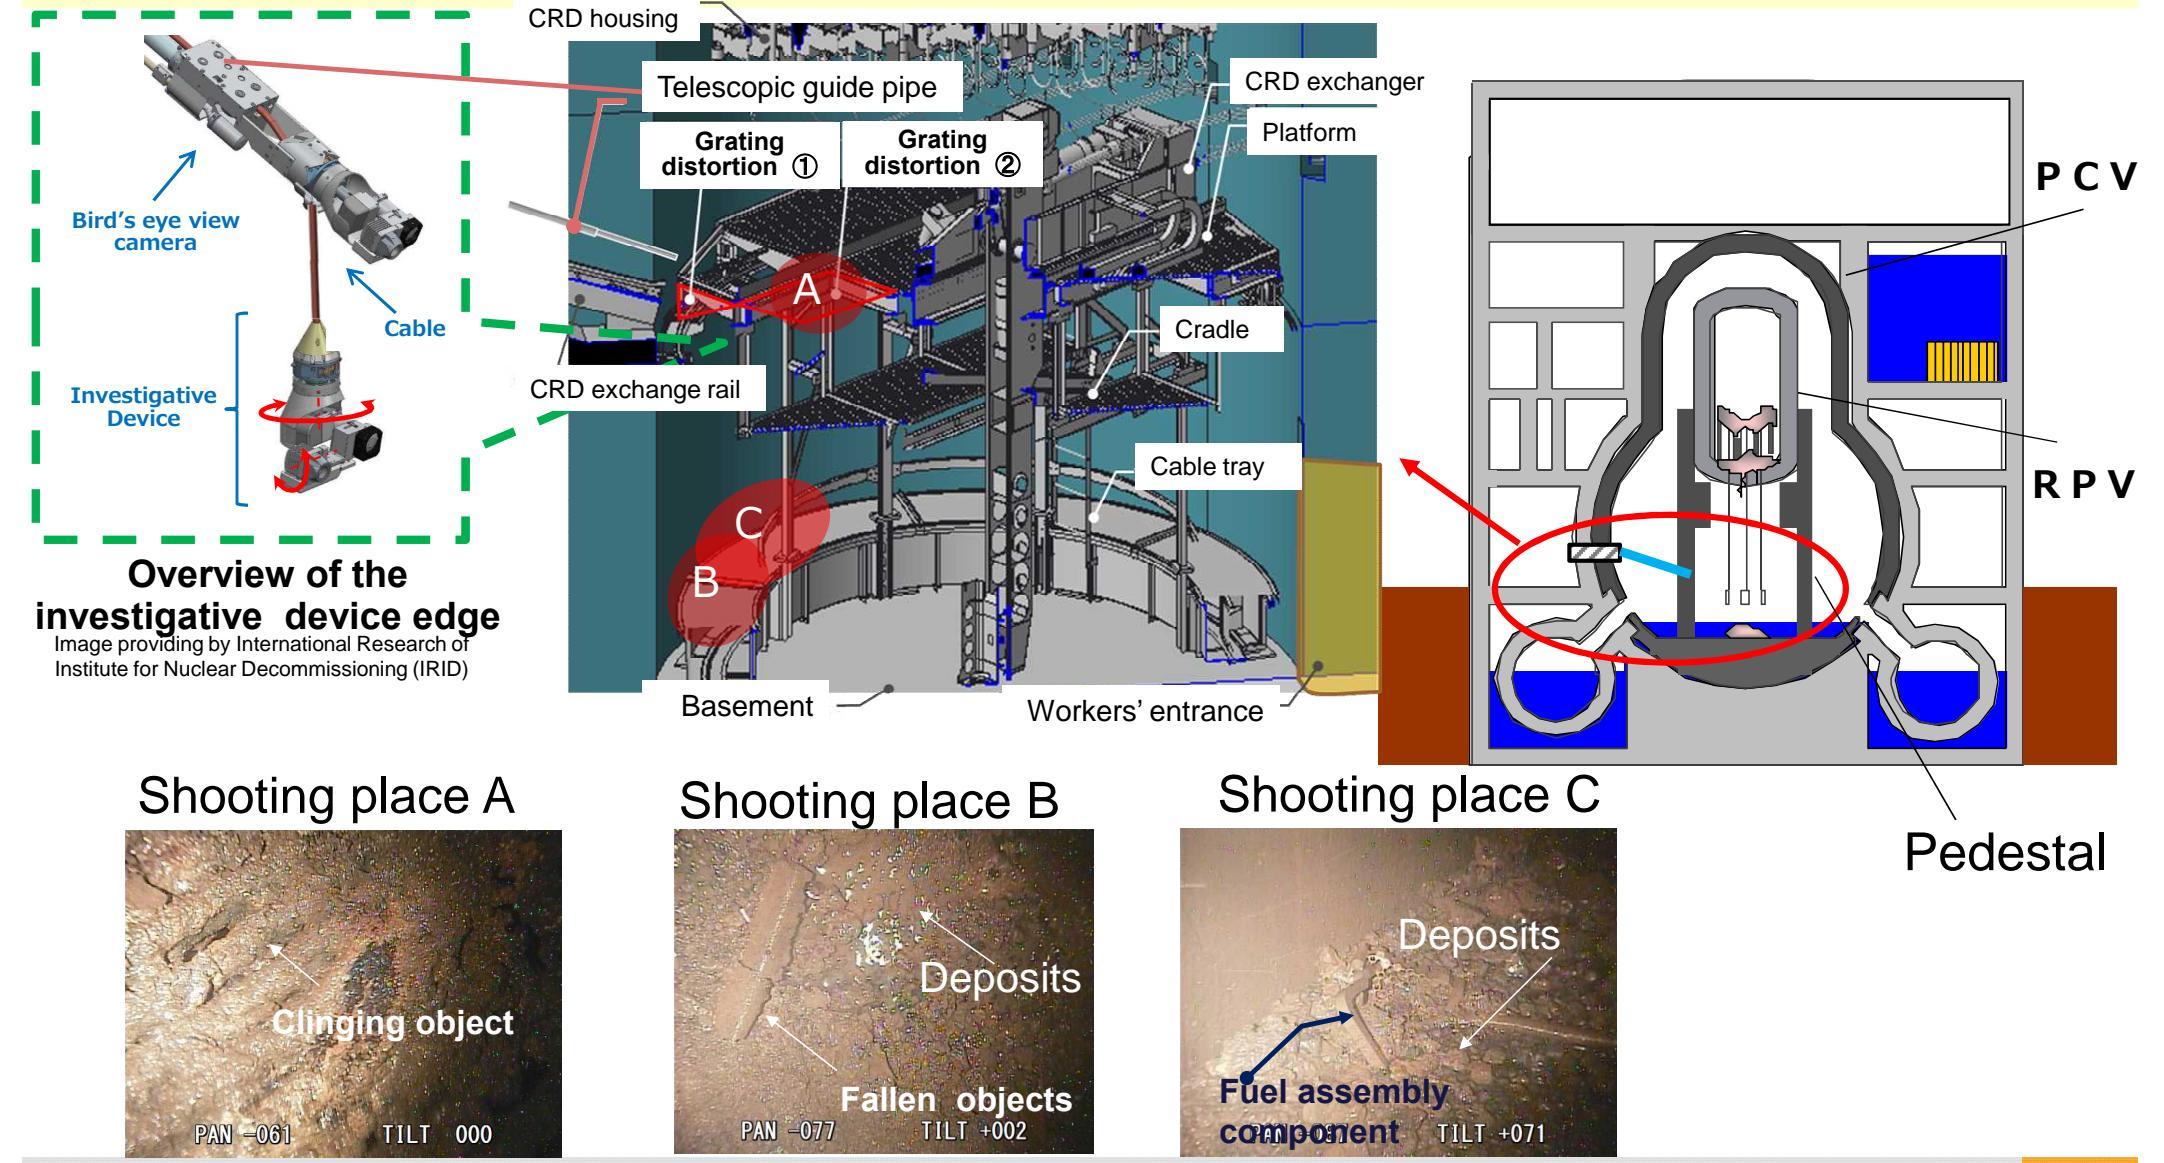
# **TEPCO** (2) Internal Investigation of Unit 2 PCV (Jan. 2018)

- An investigative device was lowered through distortion of the grating to the bottom of PCV inside the pedestal.
- Deposits thought to be fuel debris as well as fuel assembly components which were located in RPV before the accident were identified at the bottom.

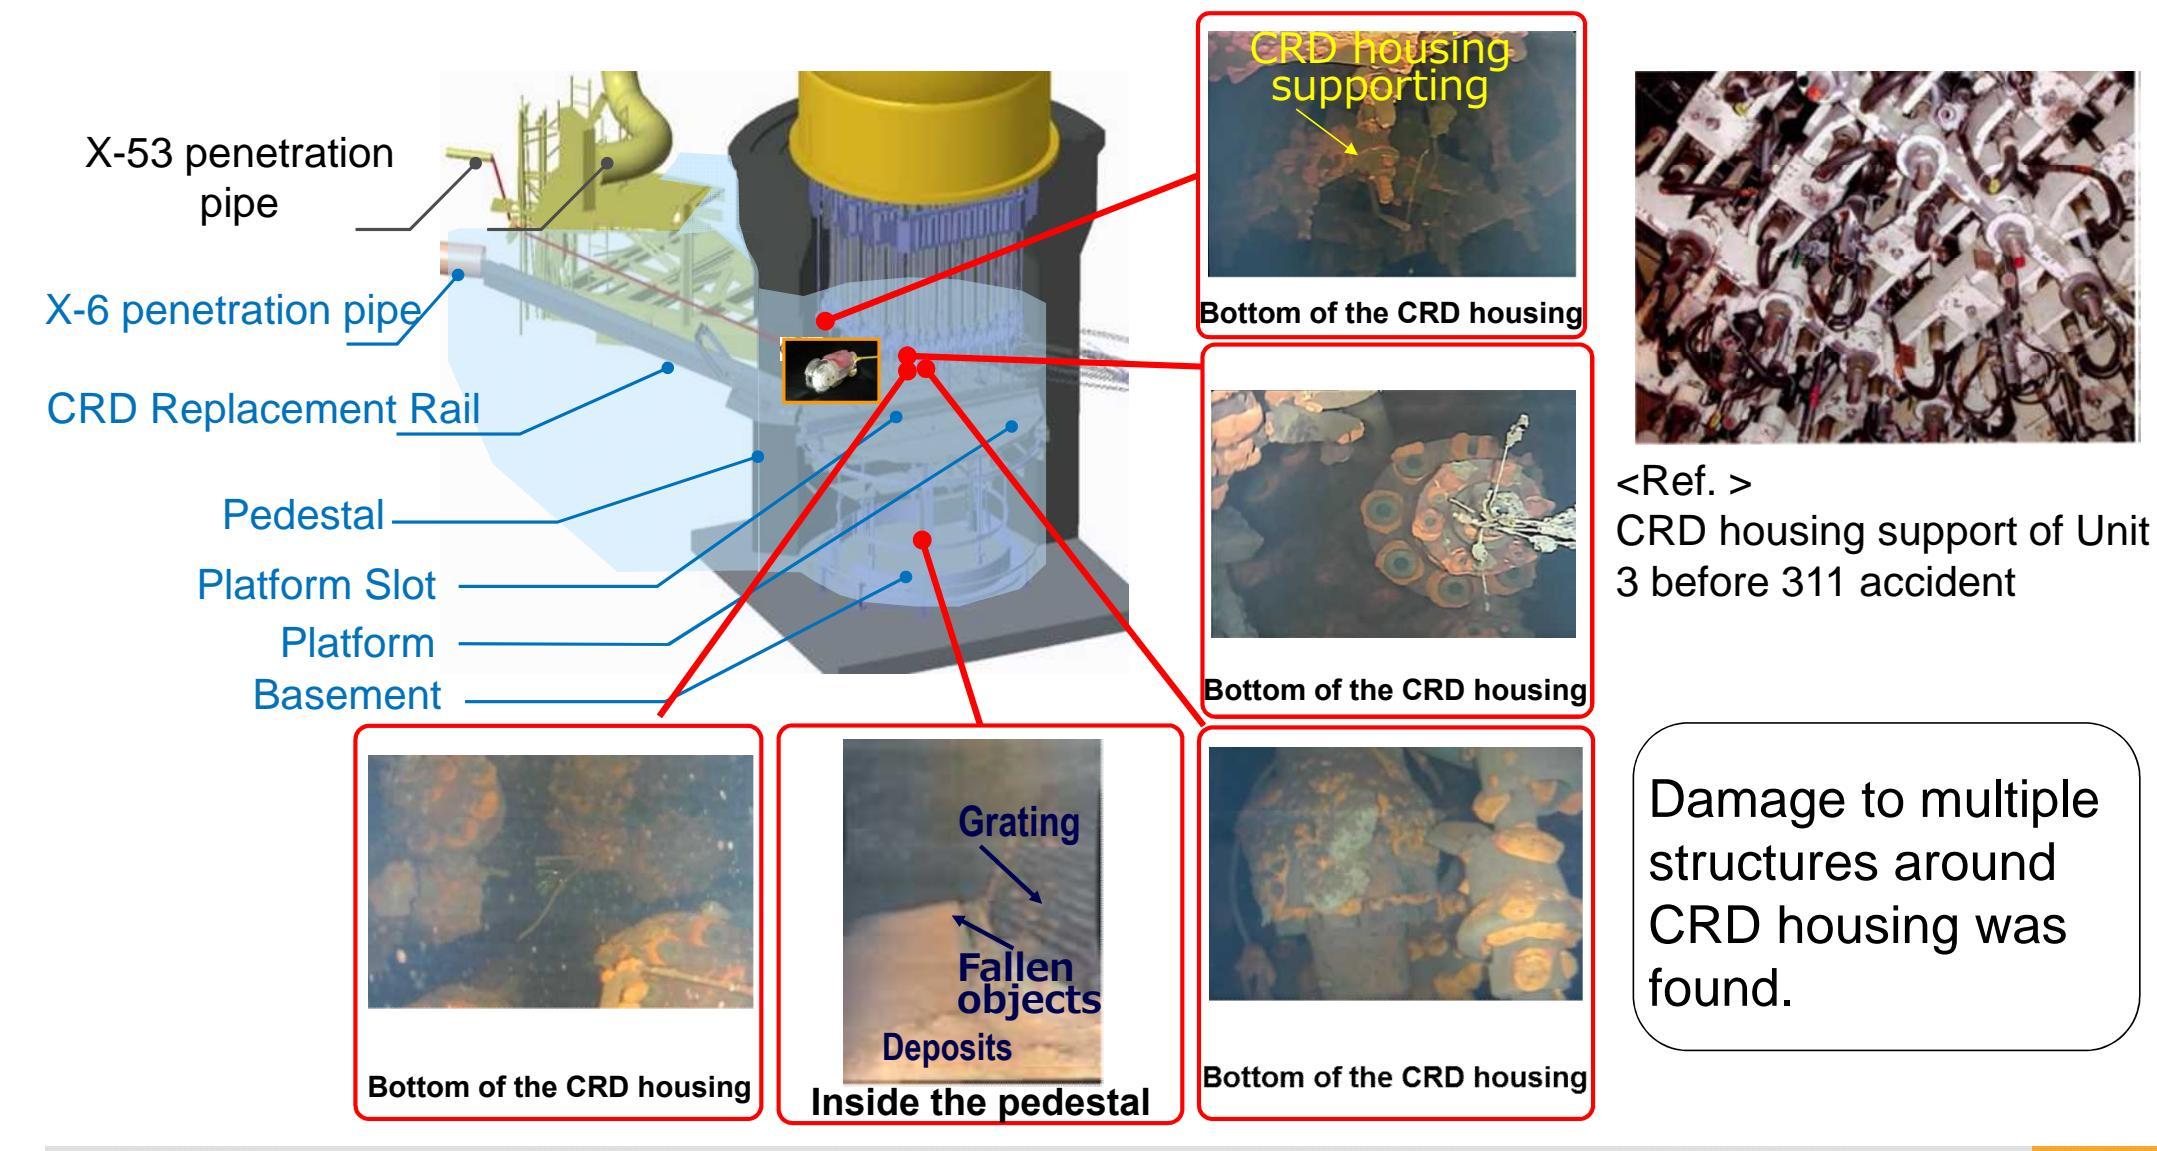
# **TEPCO** (3) Internal Investigation of Unit 3 PCV (Jul. 2017)

- Several fallen obstacles and sediments, such as solidified molten materials and grating were identified inside the pedestal.
- Analysis of image data shows, in contrast to Unit 2, a larger amount of fuel debris dropped inside the pedestal.

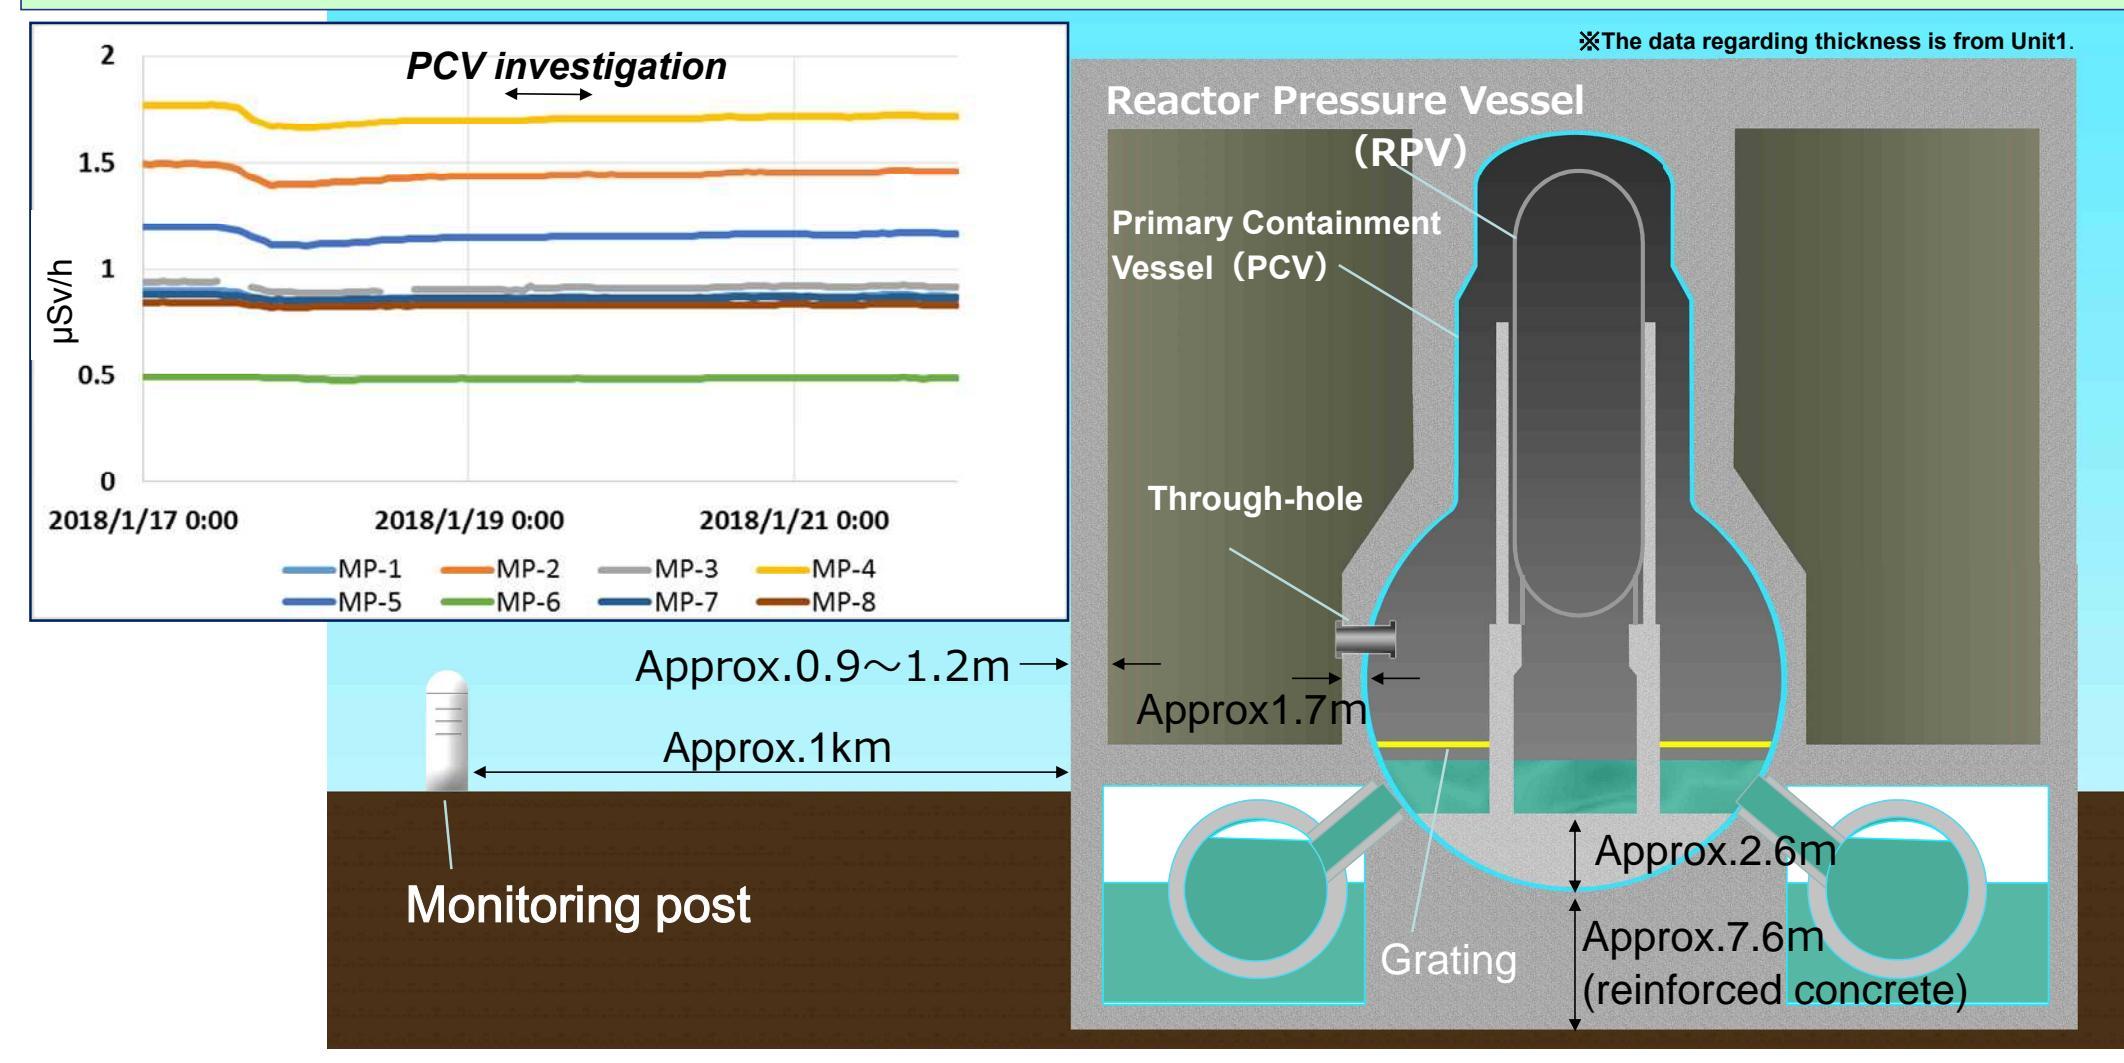
# **TEPCO** (4) Current Radioactive Impact on the Environment

Radiation in the reactors is blocked by iron and reactor buildings.
 No impact on the surrounding environment has been found after the internal investigation conducted at Unit 1 through 3 since last year.

The case on Jan 19, 2018: No change in dose rate was found after the work during the internal investigation.
