# **FPCJ Press Briefing**

# Fukushima Daiichi Decontamination and Decommissioning : Current Status and Challenges

Naohiro MASUDA Chief Decommissioning Officer, President of Fukushima Daiichi Decontamination and Decommissioning Engineering Company, Tokyo Electric Power Company Holdings, Inc.

March 2, 2018

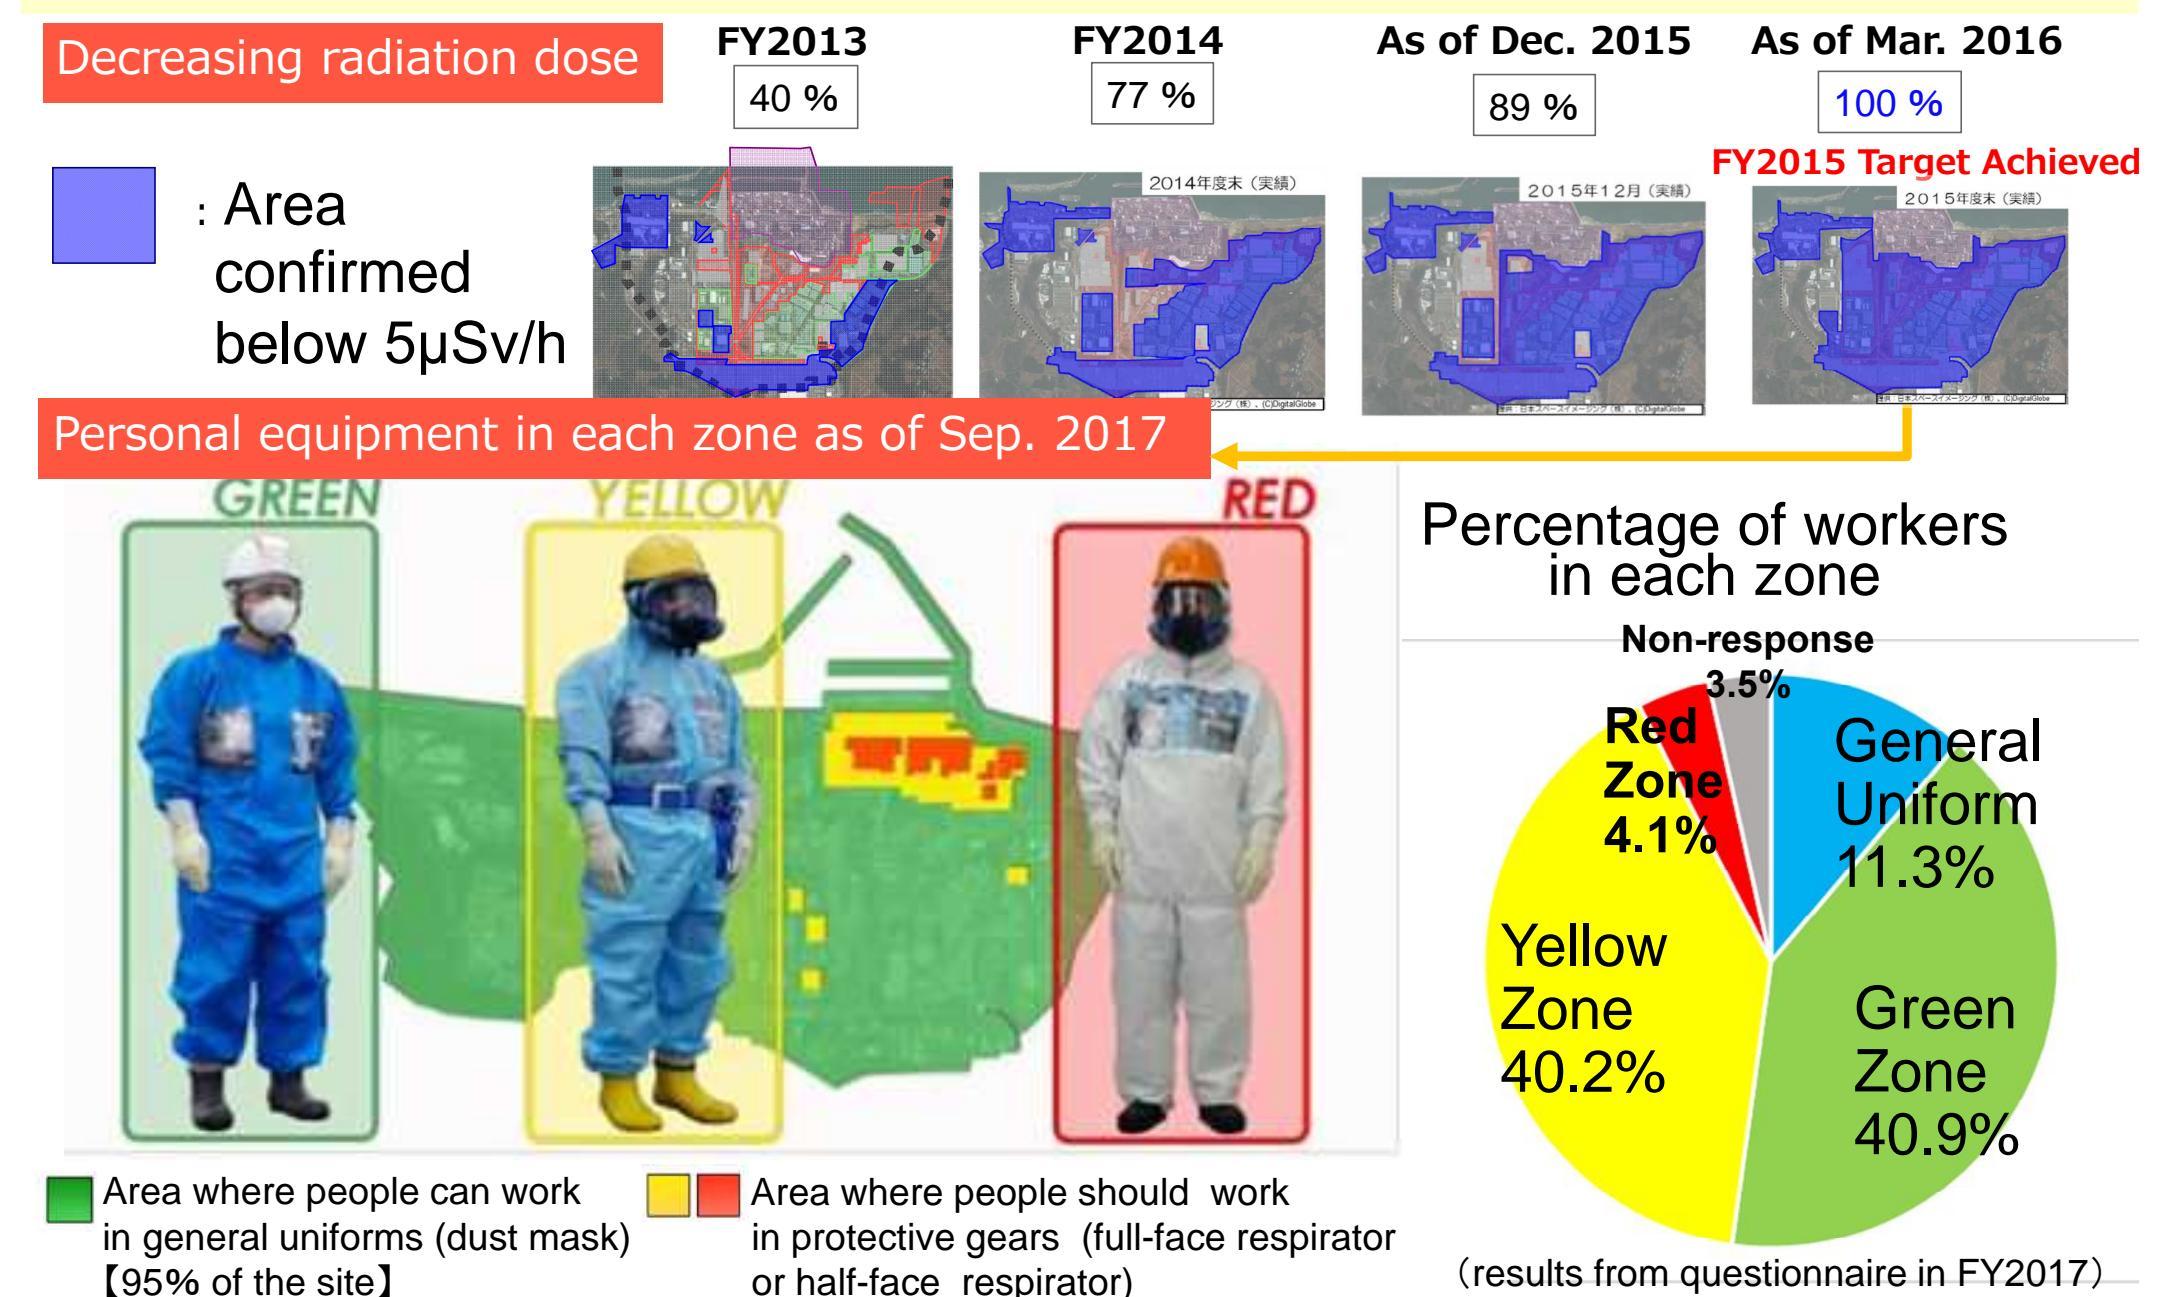
# **TEPCO** (1) Decreasing Site Radiation Dose

As a result of radiation reduction measure, workers don't have to wear full-face respirator or half-face respirator anymore in most parts of the site.
